## Building & Pest Inspection Report

##/5## ##### Avenue  
#####, Vic

August 1, 2024

Report: 6430-b&p

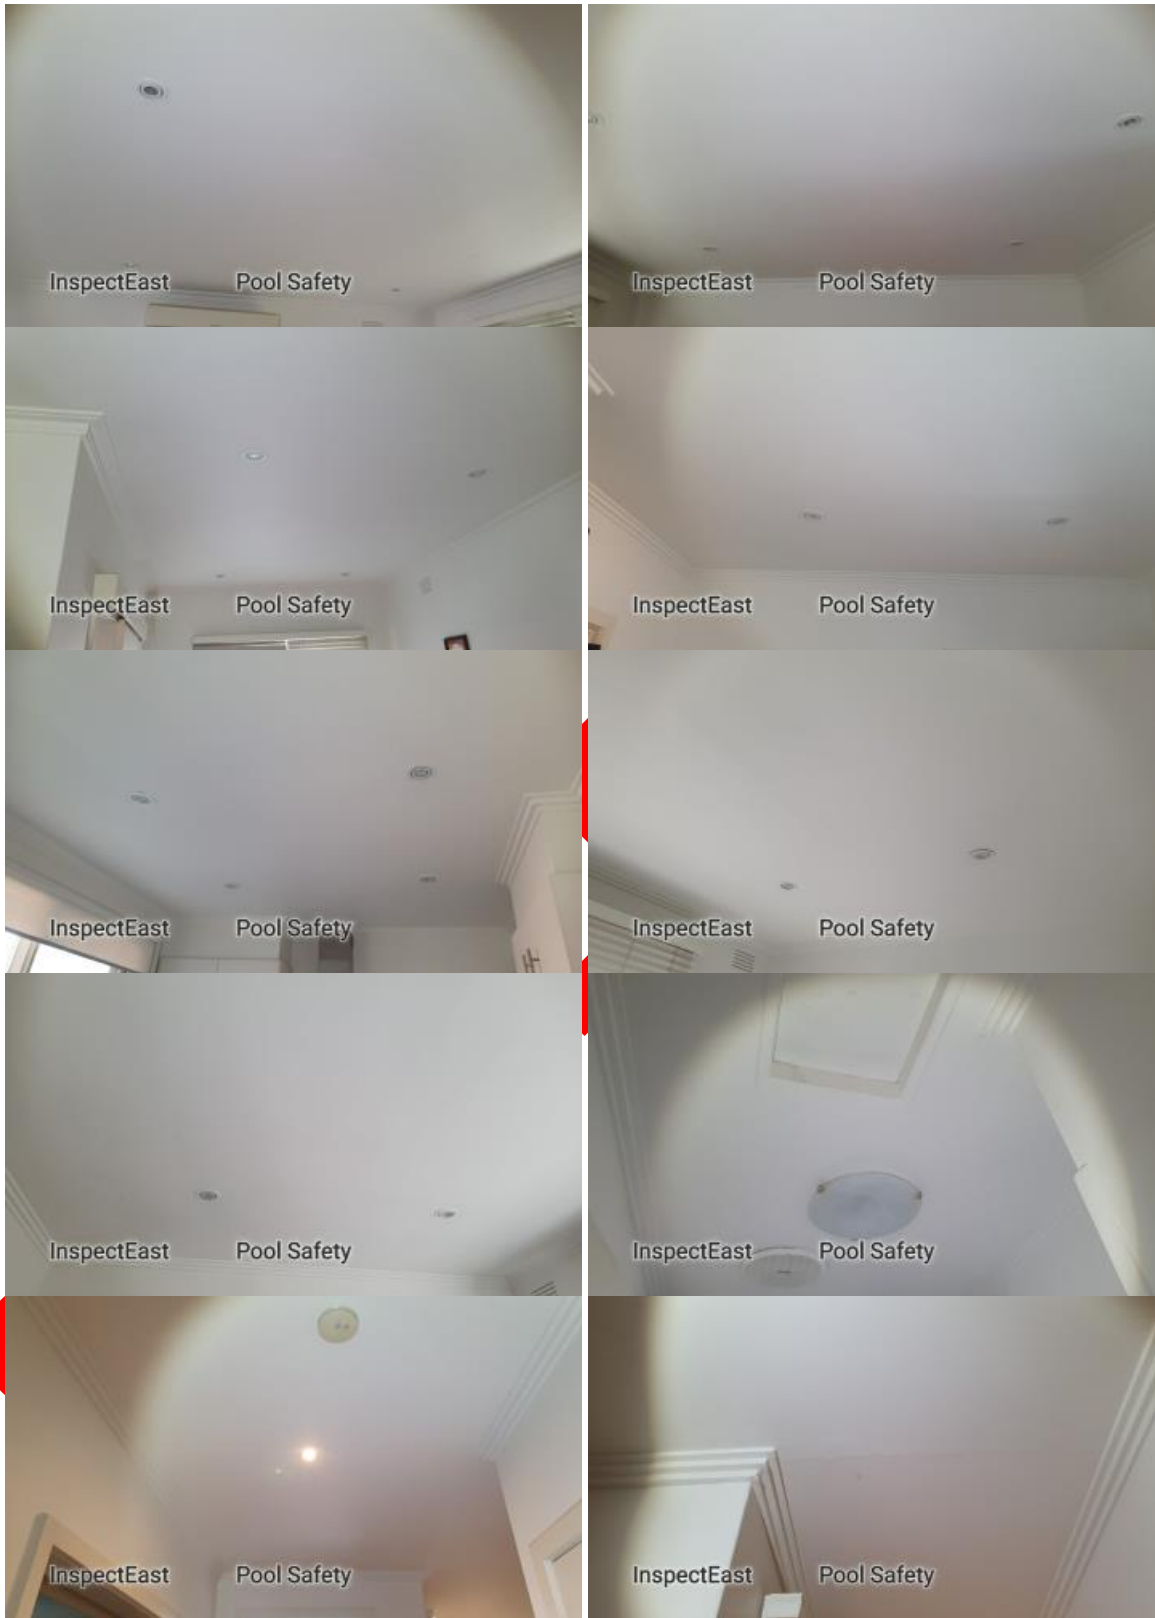
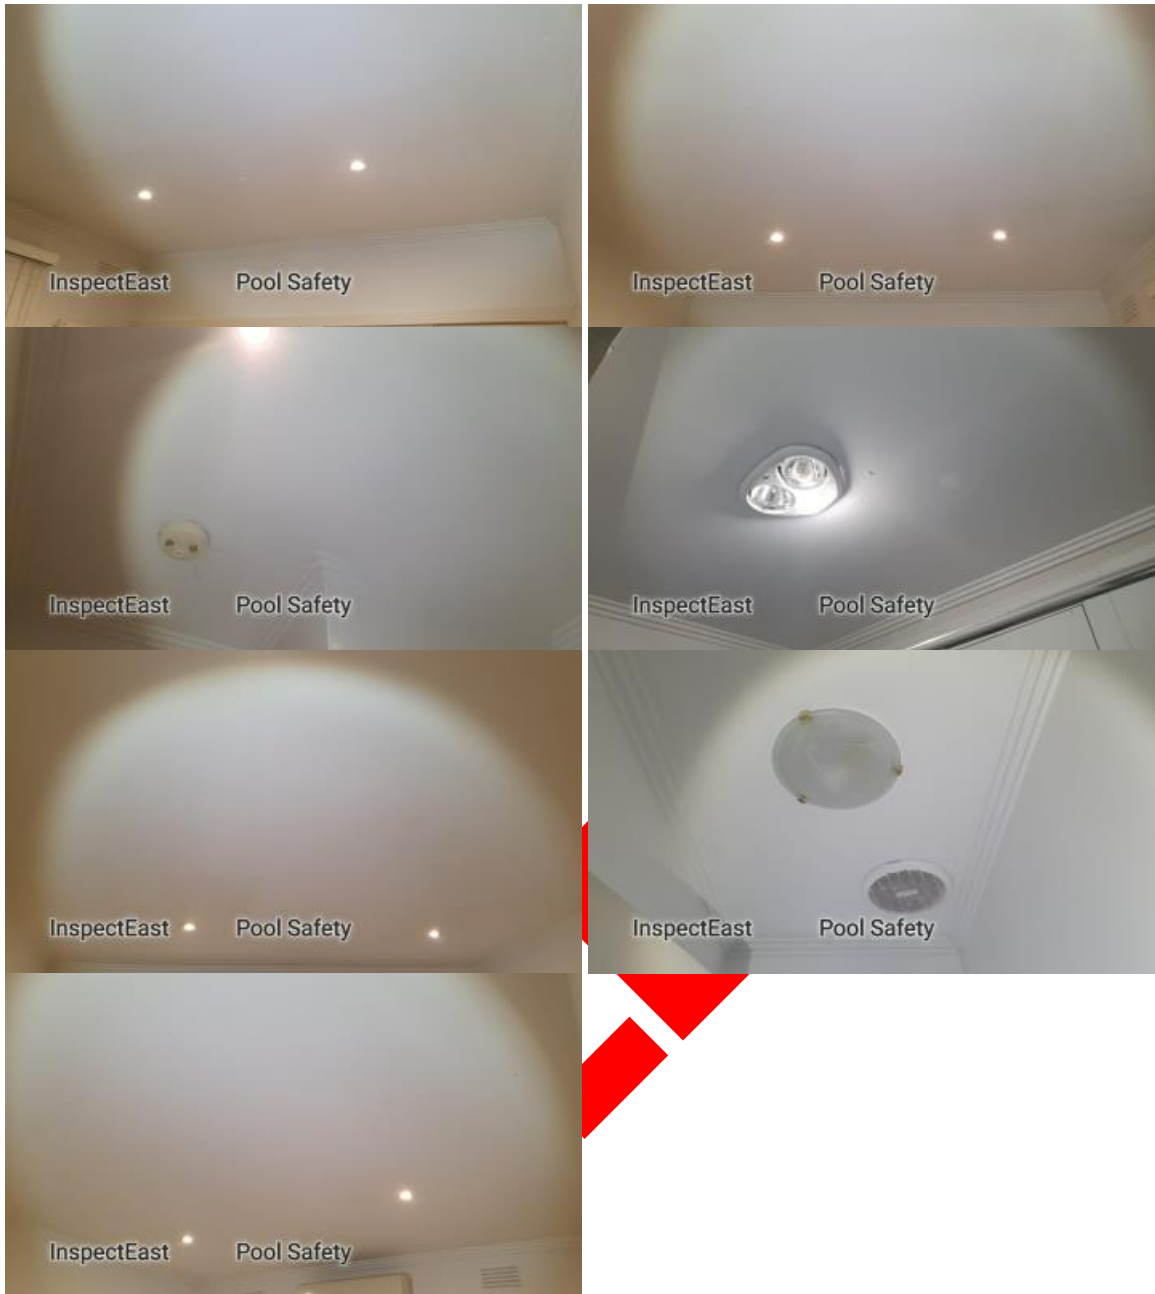
Cosmetic defective surfaces were noted to bed 1 and bathroom of the property. Maintenance will be required by a suitably qualified trades' person.

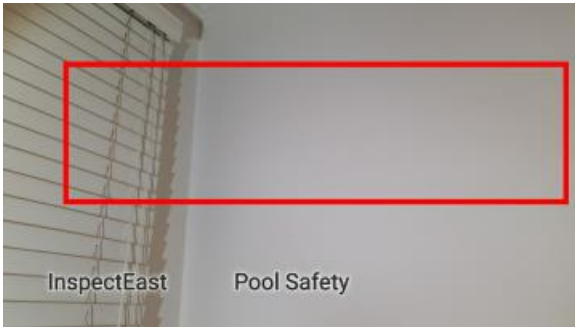
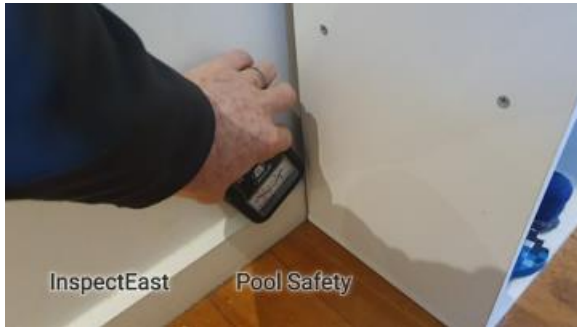
Cosmetic defective or poor surfaces were noted to wall materials within various area/s of the property and will need repair by painting by a suitably qualified plasterer and/or painter.

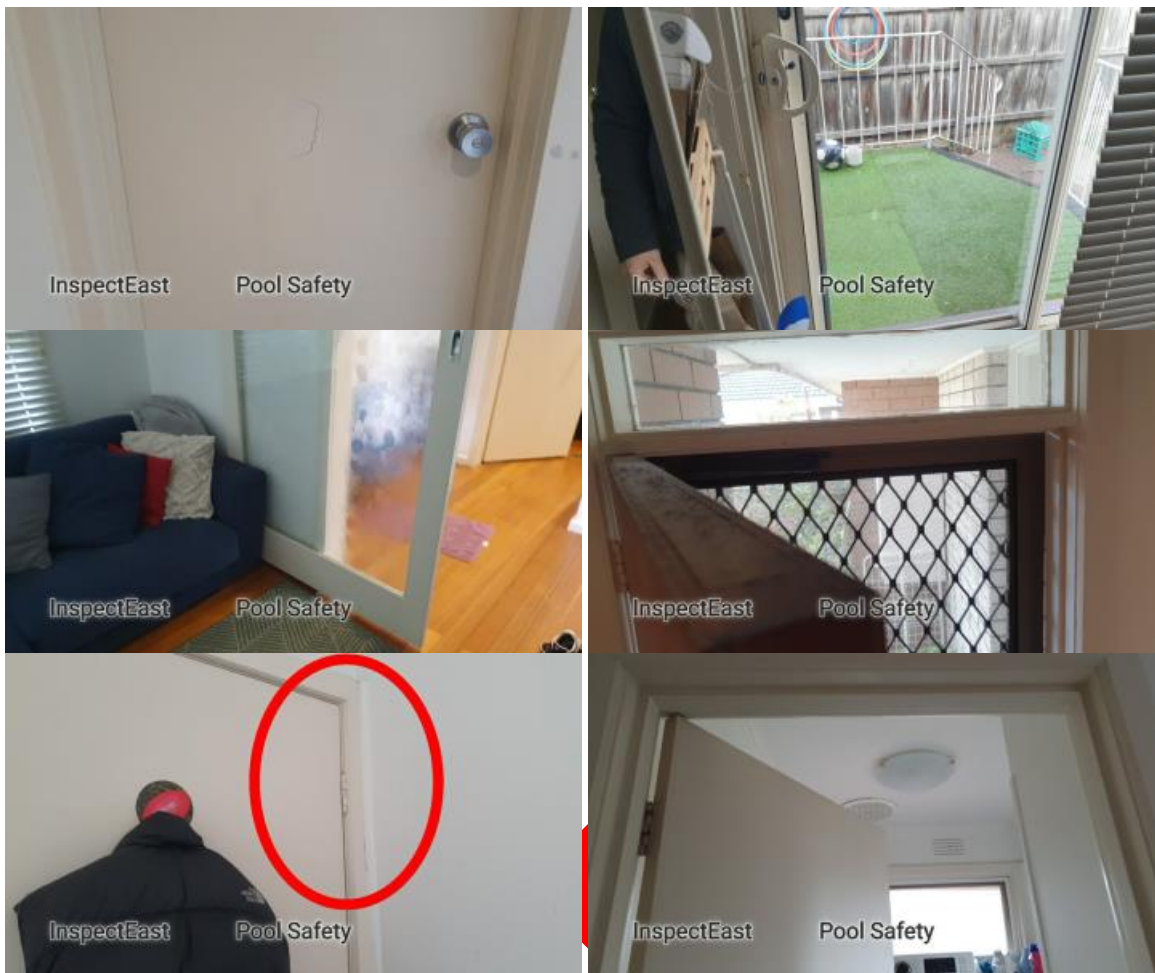
The door hinges appear old and/or damaged and require repair or replacement to the following door/s bed 3. A licensed carpenter is required to provide a further assessment and to offer suitable rectification as required.

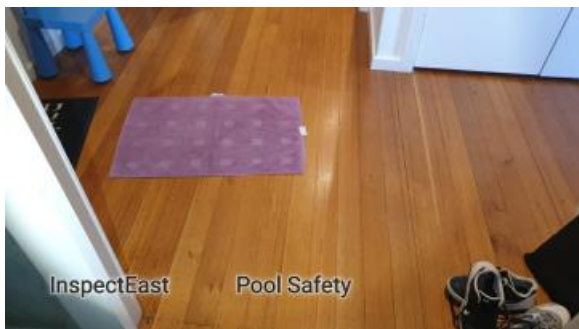
Some cracked tiles were noted to the dining. Replacement of cracked is recommended. A professional tiler should be called to conduct suitable repairs.

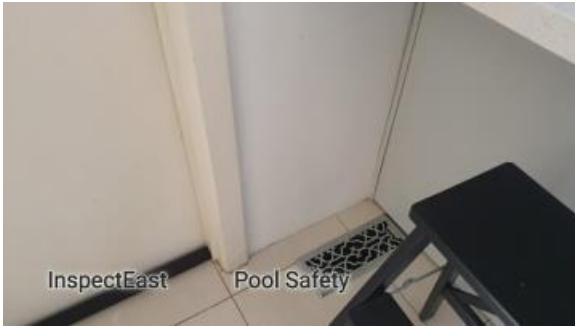
Skirting boards(s) are missing within the kitchen and will require replacement. A licensed carpenter is required to provide a further assessment and to offer suitable rectification as required.

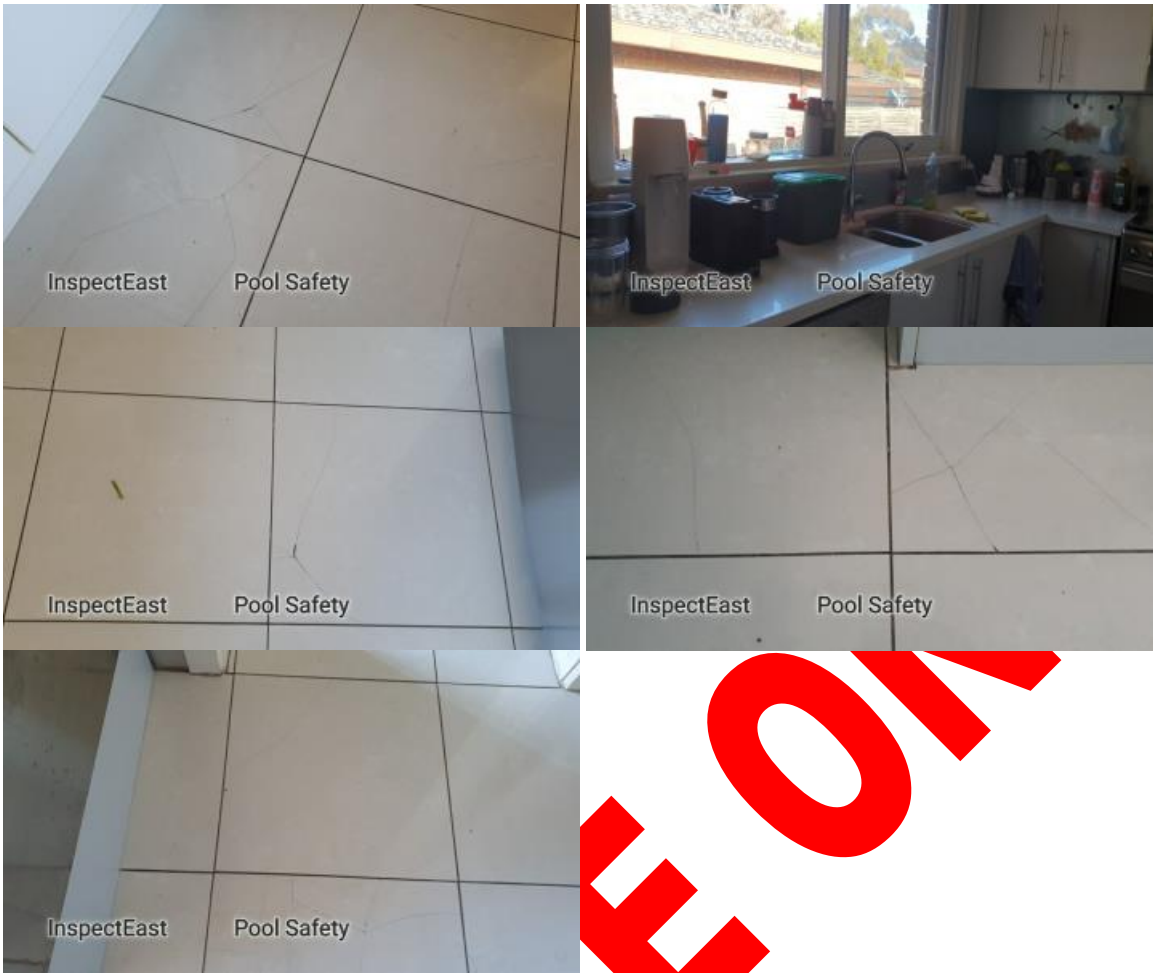
Some tiles are cracked and drummy (loose) to the kitchen floor. Repairs are required, and any damaged tiles should be replaced by a tiler to prevent water penetration and decay to surrounding components.

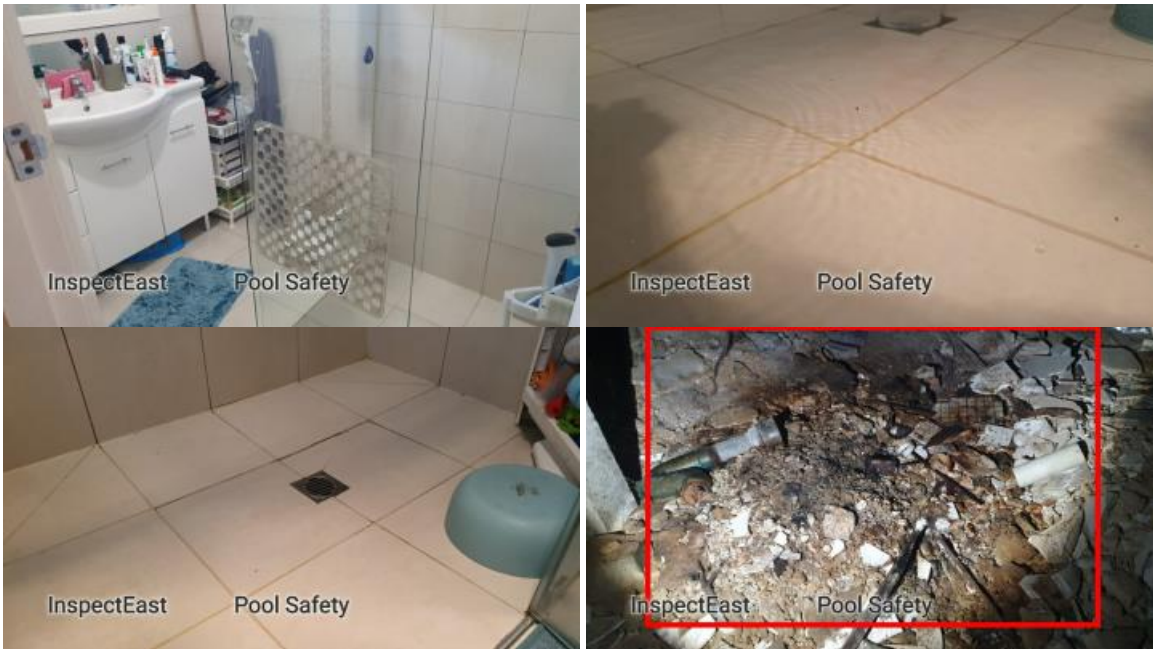
Note: The base structure positioned to the underside of the tiled shower base is not providing adequate support to the underside of the shower. Repairs and or additional support is required to ensure the area is suitably supported, without the correct support movement and deterioration of grout, tiles and waterproofing can occur. This can allow water to penetrate surrounding areas and cause further deterioration. A licensed carpenter is required to review and carry out suitable repairs.

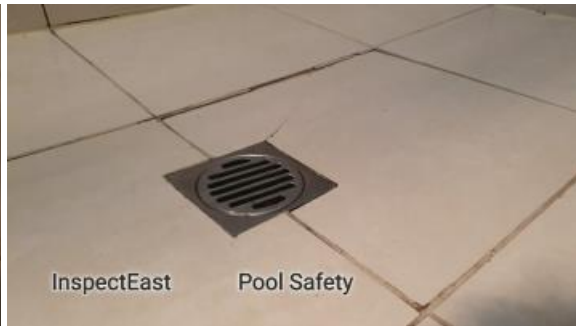
Some tiles are drummy (loose) and cracked to the shower alcove and bathroom floor. Repairs are required, and any damaged tiles should be replaced by a tiler to prevent water penetration and decay to surrounding components.

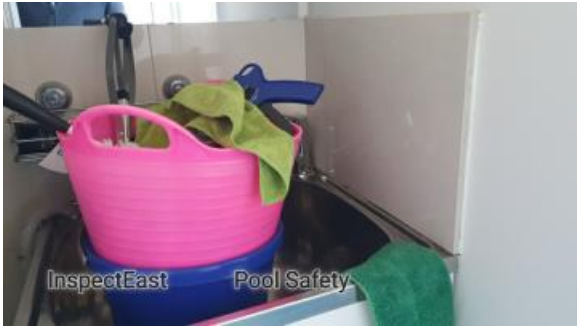
A flexible sealant should be installed by a suitably qualified professional to the gaps between tile base and laundry tub. This is to prevent water penetration and decay to surrounding components.

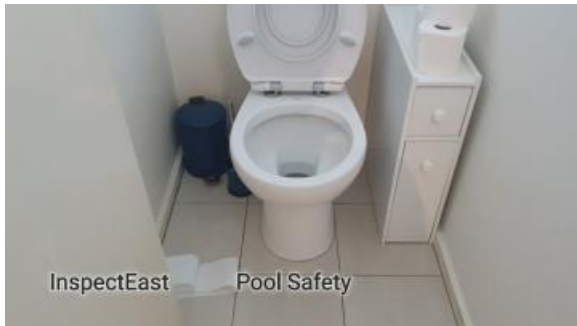
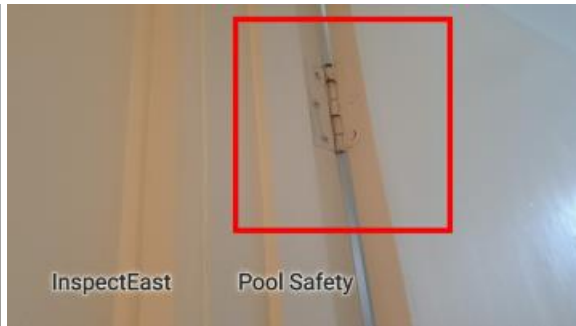
The toilet area is restrictive as the toilet door swings inwards. In case of an emergency, the door cannot be easily removed from the outside. Recommend that lift off door hinges be installed by a carpenter to comply with the current safety standards.

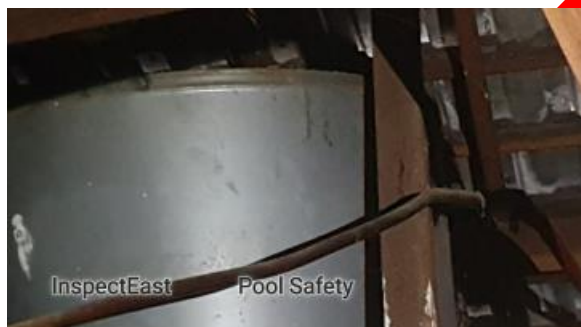
A hot water tank and support frame is present in the roof void restricting inspection of this area. We recommend the unit be removed by a suitably qualified professional to enable a more complete inspection to be conducted.

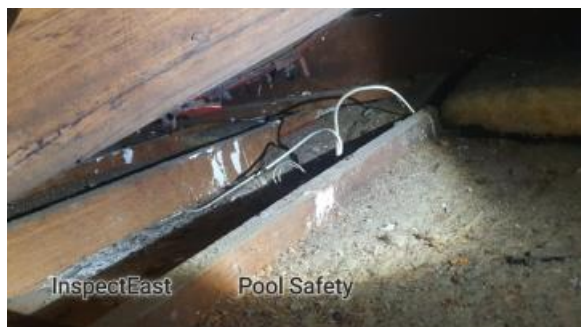
The insulation visible is not thick and full and is poorly distributed. It is not fit for purpose. We recommend that it be replaced by a suitably qualified professional to improve the overall thermal performance of the dwelling.

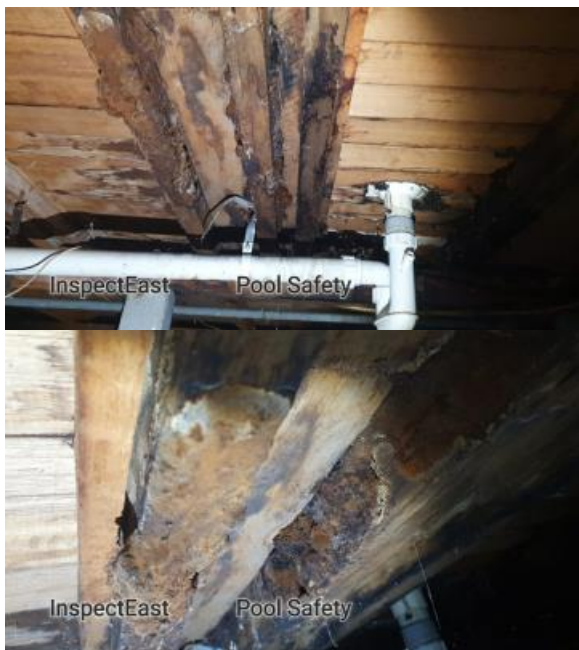
Damaged timbers require replacement without delay to assure the structure remains stable, the joist/s and flooring timbers are decayed, further concealed timbers may also be decayed. A licensed carpenter or licensed builder is required to provide a further assessment and to offer suitable rectification as required, and the source of the water leak repaired by a licensed plumber to prevent further deterioration.

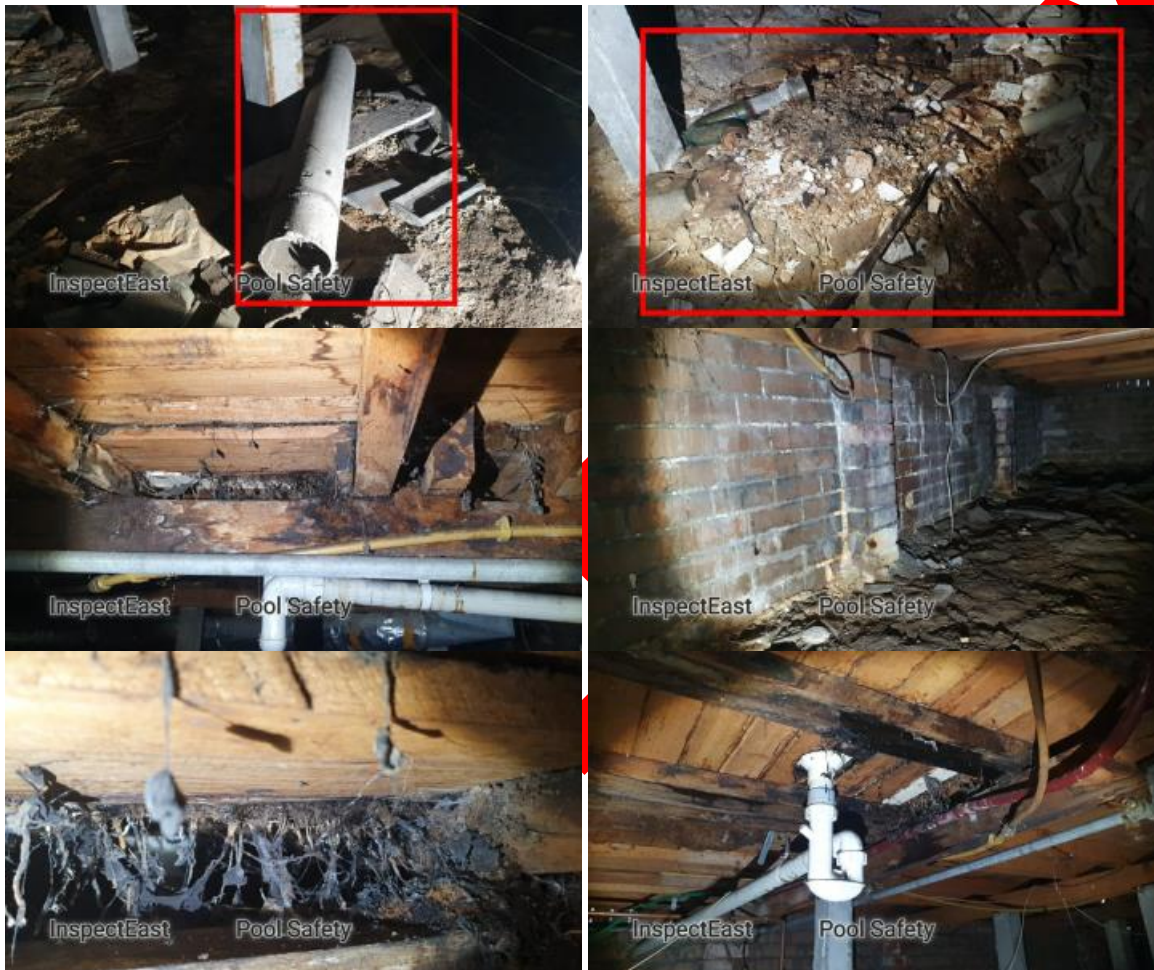
Leaks were noted in the drainage pipes under the bathroom. This has led to major decay. Please refer to the appropriate sections of the report for further details.

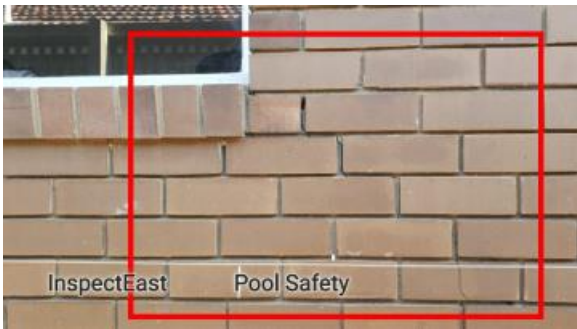
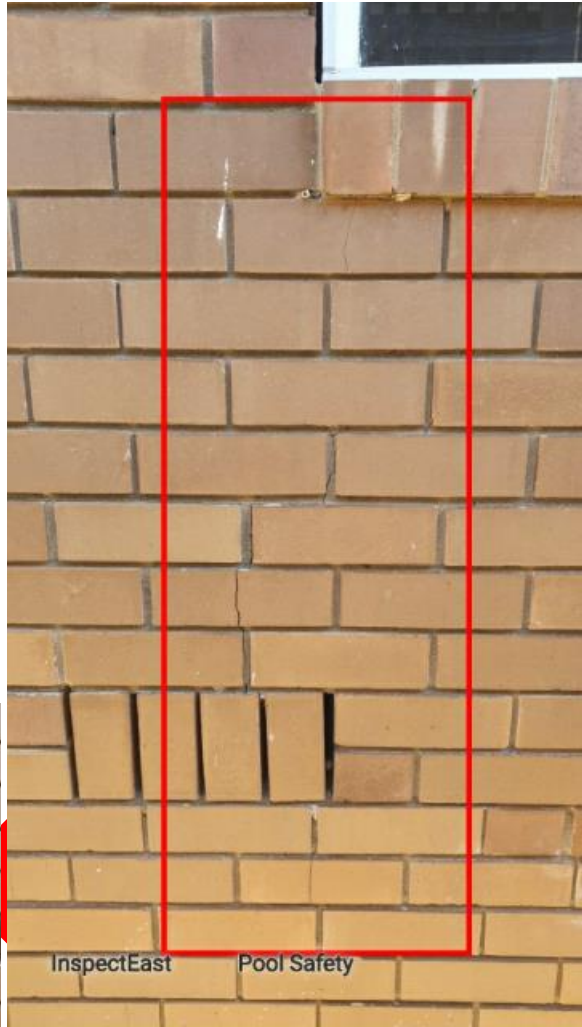
Cracks and/or evidence of movement is evident to the eastern and southern elevation/s of the property. Visible cracking has been categorized as a serviceability defect. Cracking of a building element is a serviceability defect where in the opinion of the inspector the function of the building element is impaired however, the expected consequence of this cracking is unknown until further information is obtained. A structural engineer should be called to make a further evaluation and repairs or rectification as needed.

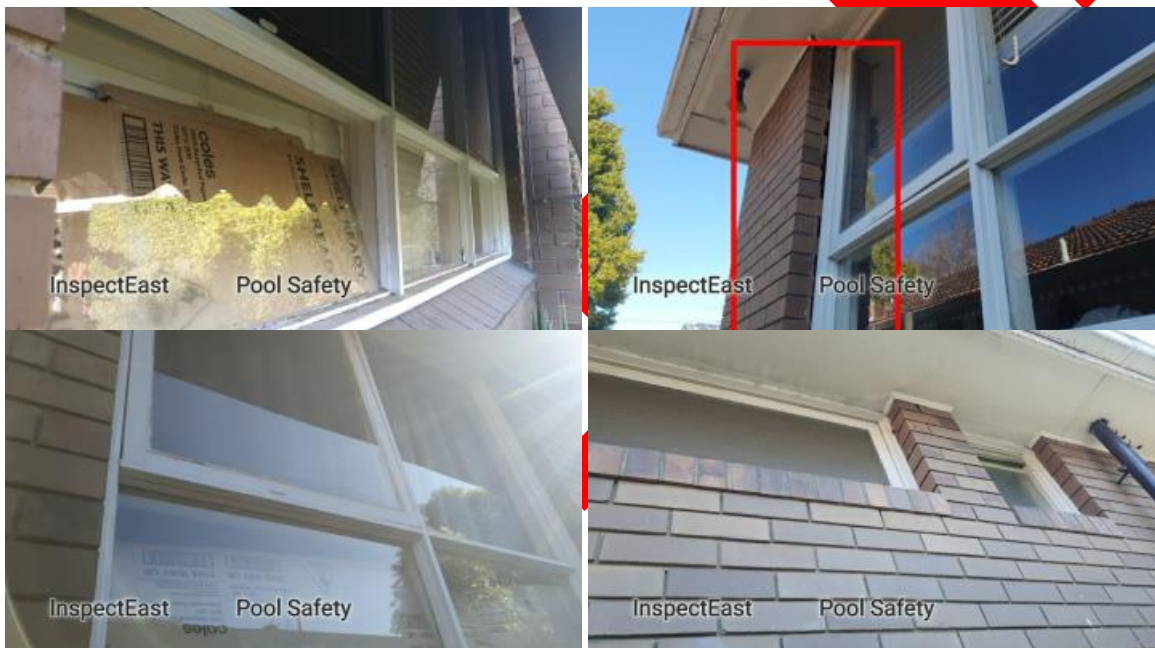
Moderate rot and or decay is present to the window frames. Maintenance, repair and/or replacement will be required by a qualified carpenter. This was observed to the western side/s of the property. A licensed carpenter required to provide a further assessment and to offer suitable rectification as required.

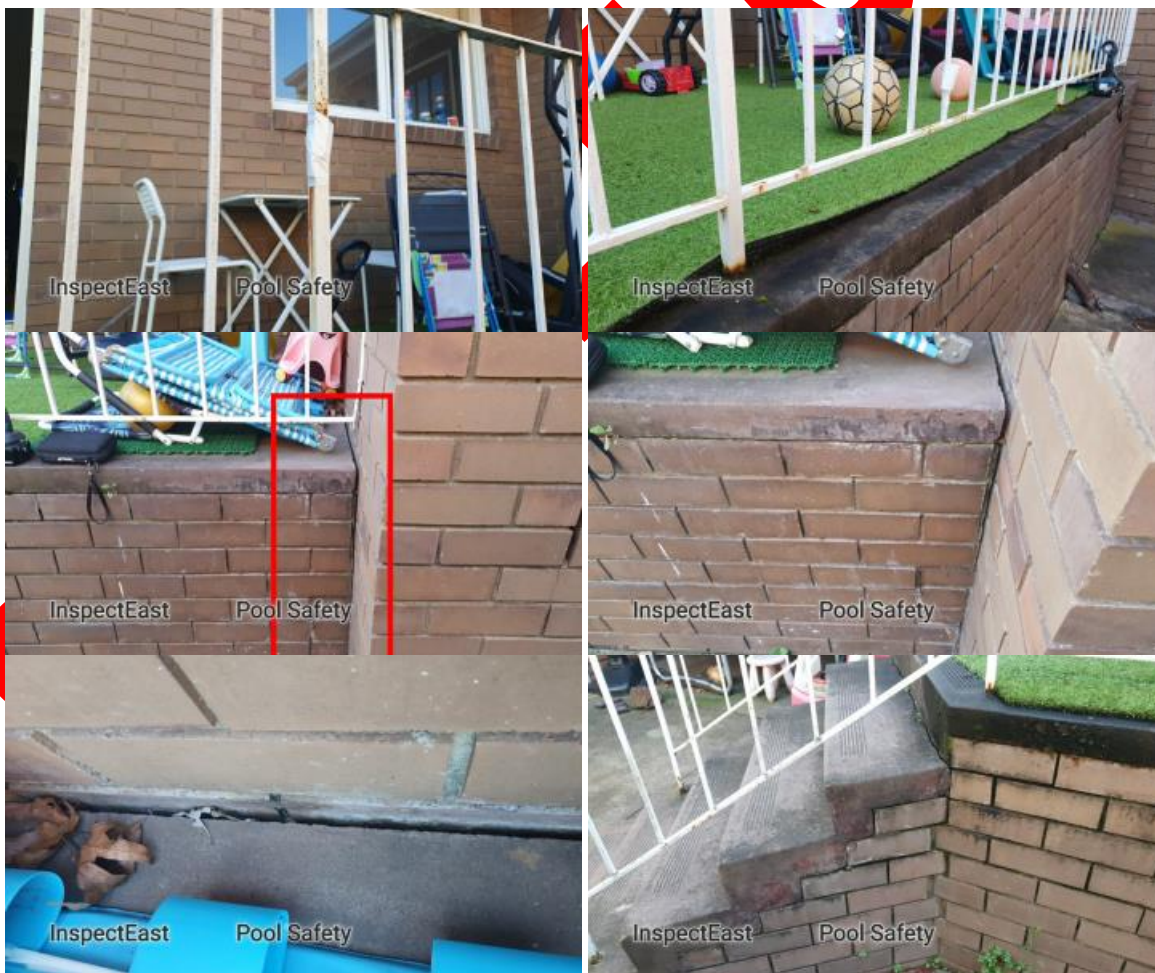
Minor to moderate movement is evident to the concrete stairs. This will require some maintenance or repair by a concreter, as its possible this movement may present as a safety issue in the future.

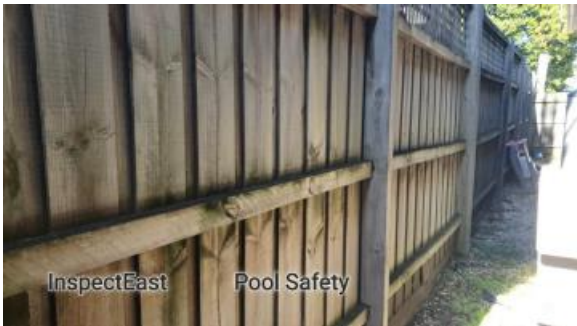
Note: Repairs or maintenance is required. The fences are leaning to the rear side/s of the property. We recommend repairs are carried out by a licensed carpenter to assure the fences remain secure.

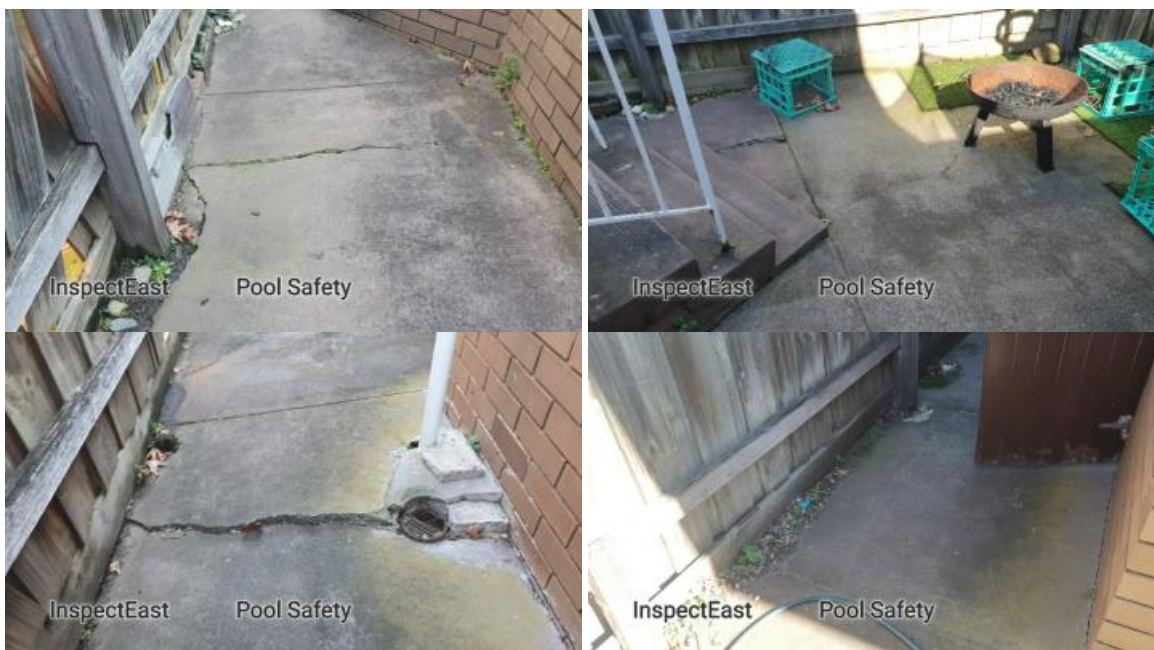
**Note:** This presents a potential safety hazard and we recommend immediate repairs be undertaken.

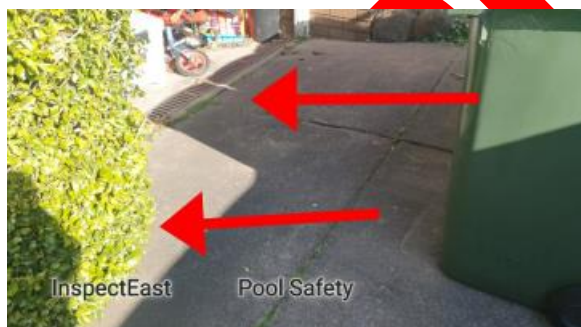
The drainage to the garage appears inadequate. This was observed to the front elevation/s. Poor site drainage can create unstable foundations and/or destabilise the foundations that may have an adverse structural effect to the dwelling. Rectification is required. Drains should be installed to divert seepage and surface runoff water away from the house. The drains should be connected to the existing stormwater drainage system. Please contact a licensed drainer/plumber and/or licensed builder to make a further assessment and to offer suitable rectification advice.

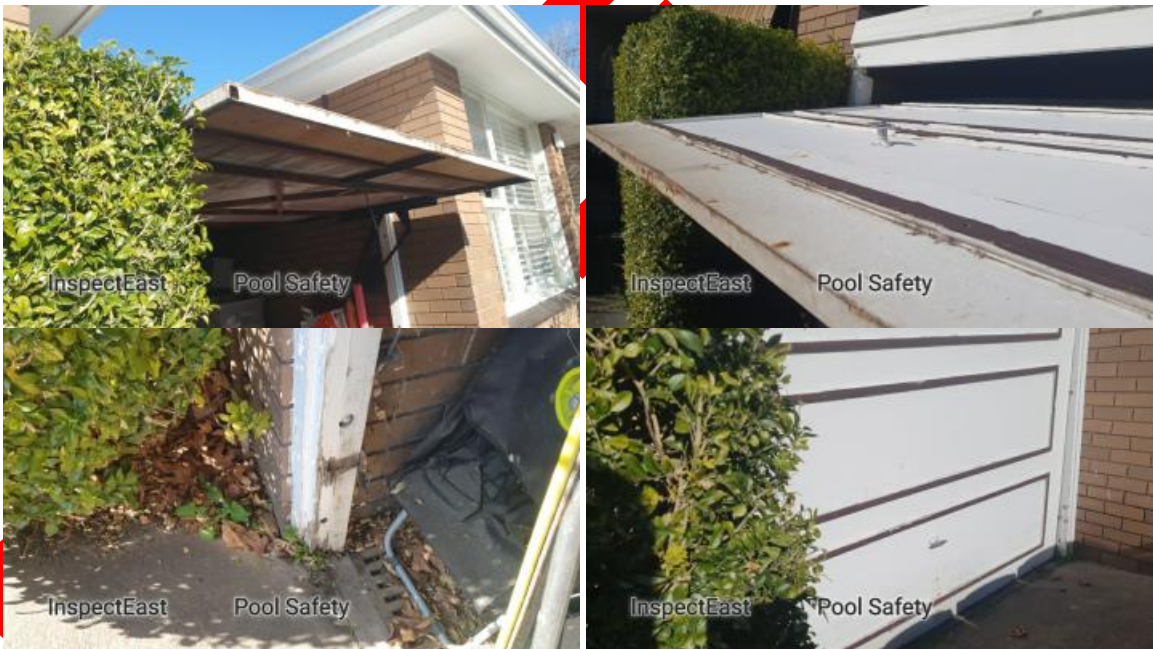
Minor rust is evident to the door. This may reduce the service life of the door. This should be treated to prevent further deterioration.

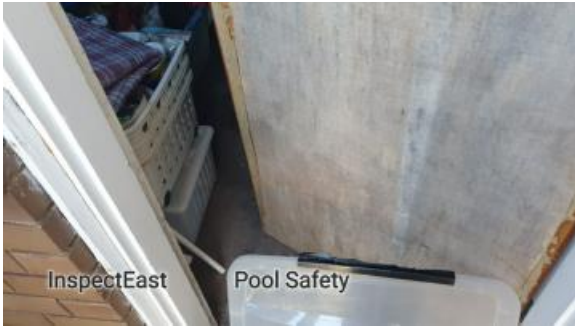
Weather strips should be installed to the external garage door/s to prevent water entry which could lead to wet rot decay. A licensed carpenter is required to provide a further assessment and to offer suitable rectification as required.

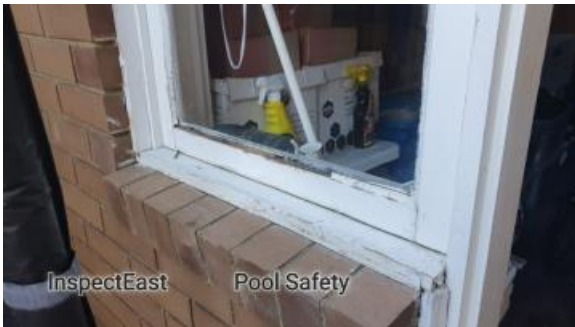
Putty within the windows have deteriorated and requires repair to prevent water penetration and decay to surrounding components. A licensed glazier is required to provide a further assessment and to offer suitable rectification as required.

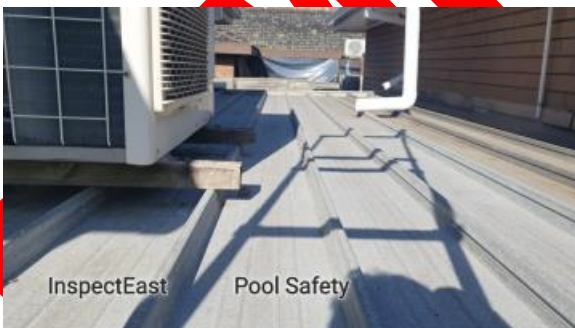
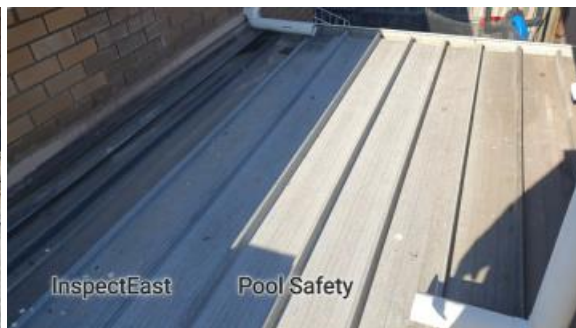
The pitch of the pitched roof appears to be to flat to the garage. This may allow wind driven rain penetration or water ponding and rectification is required. A licensed roof tiler is required to provide a further assessment and to offer suitable rectification as required.

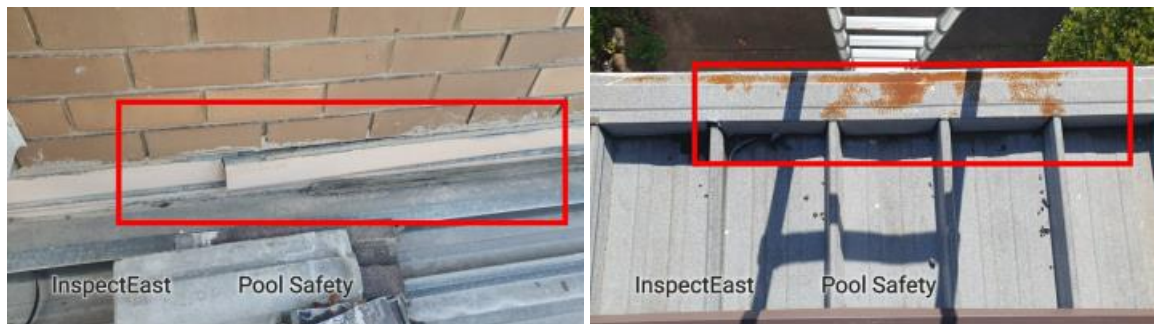
Metal roof flashing/s are surface rusted to the garage roof and treatment with an anti-rust paint is required to prolong the life of the material. A licensed roof plumber is required to provide a further assessment and to offer suitable rectification as required.

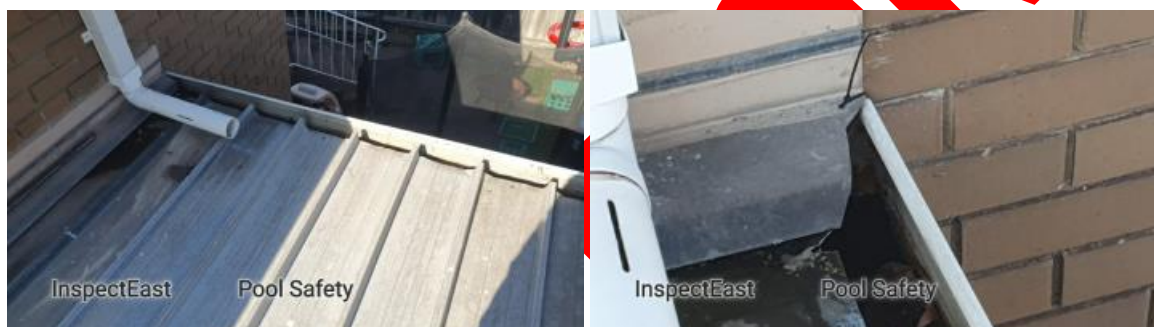
Note:- The damage present appears to be the support system for the gutter system.

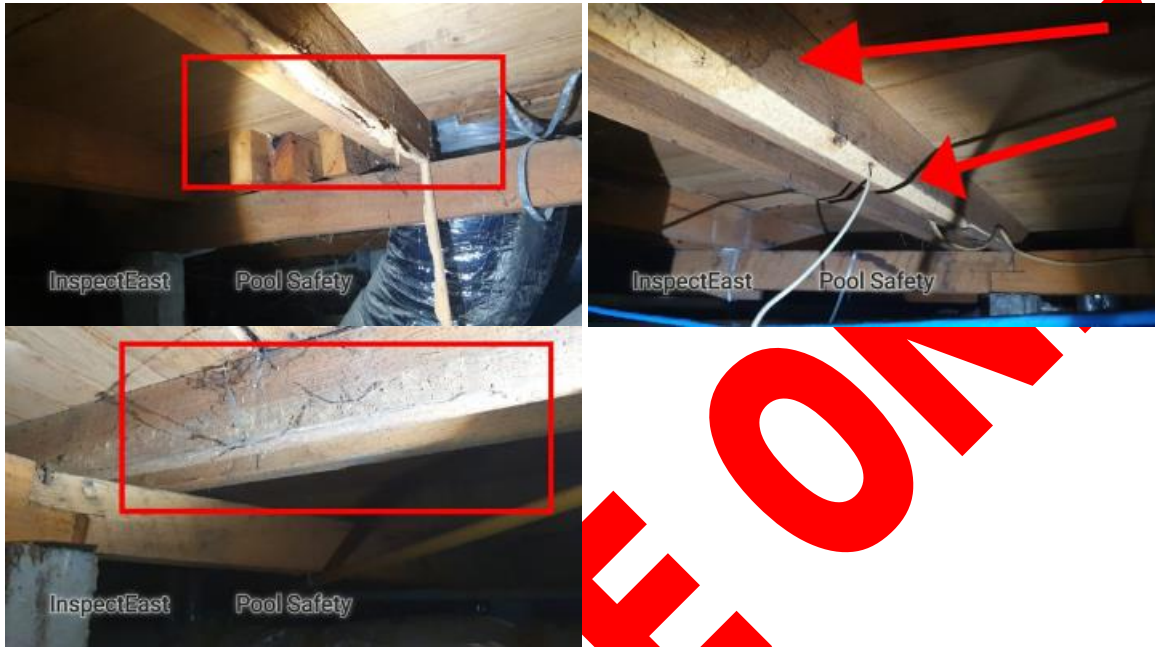
Evidence of Lyctus borer was found. Lyctus borer is not considered to be a significant pest of timber and as the damage is confined to the sapwood content of hardwood timbers, no treatment is required in respect of this borer. Lyctus borer damage was noted to the following timber(s)/area(s).
