## Building & Pest Inspection Report

##/5## ##### Avenue  
#####, Vic

August 1, 2024

Report: 6430-b&p

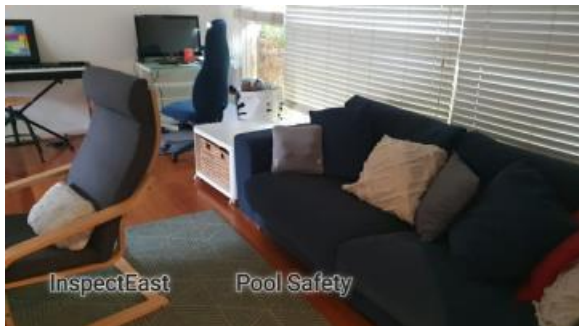
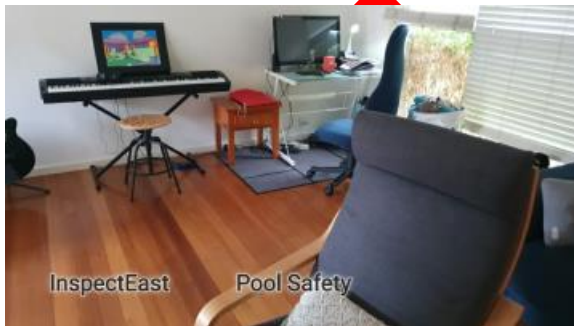
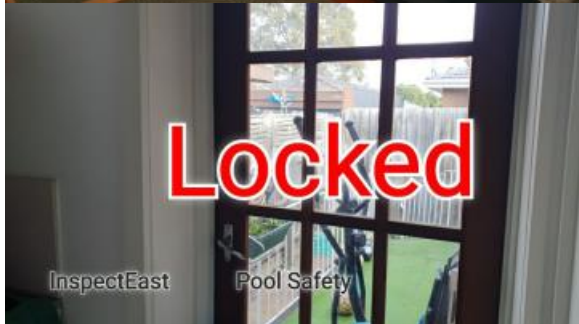
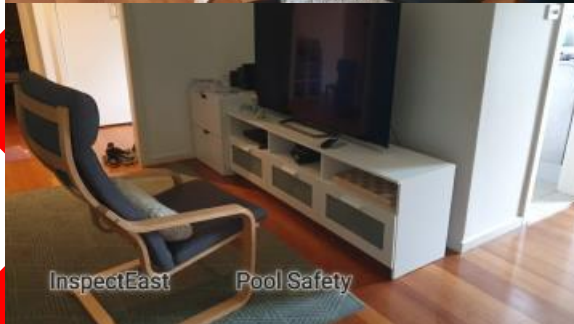
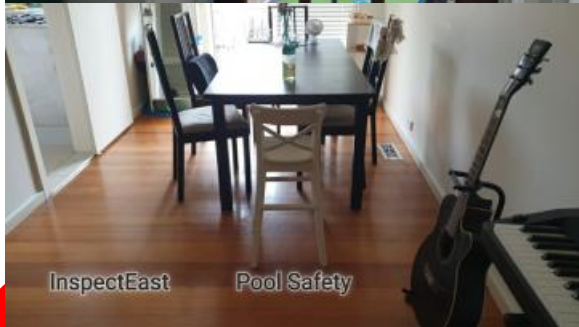
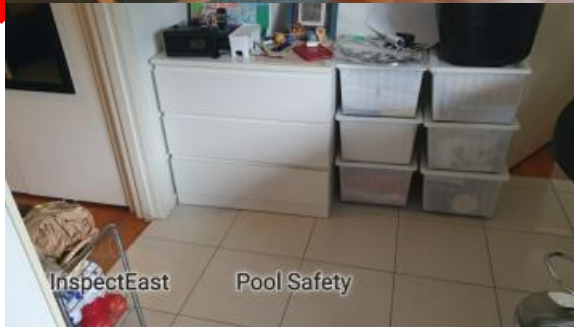
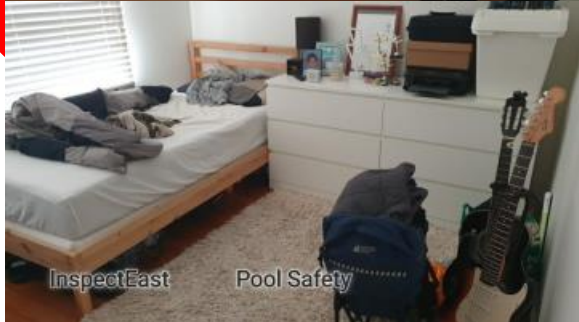
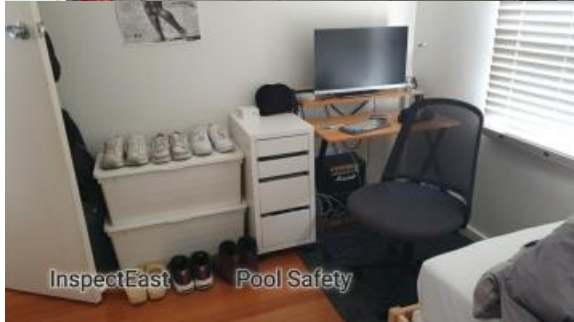
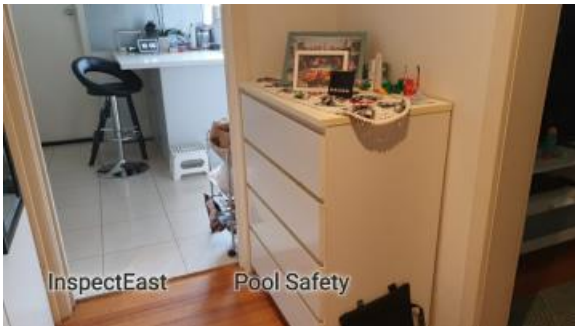
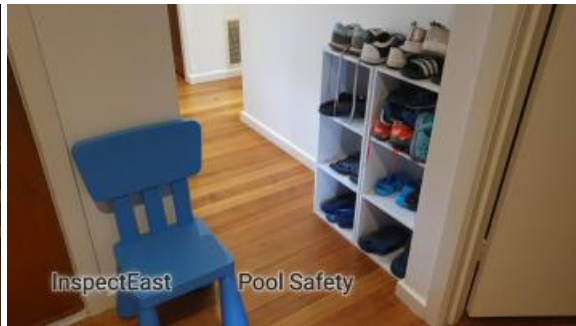
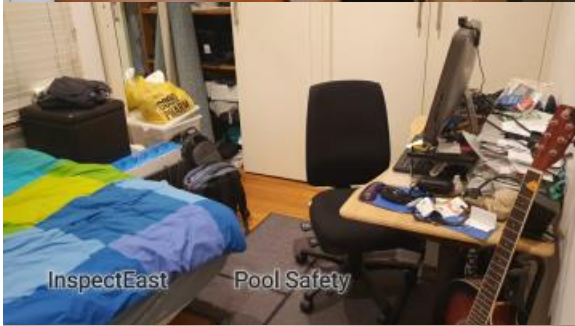
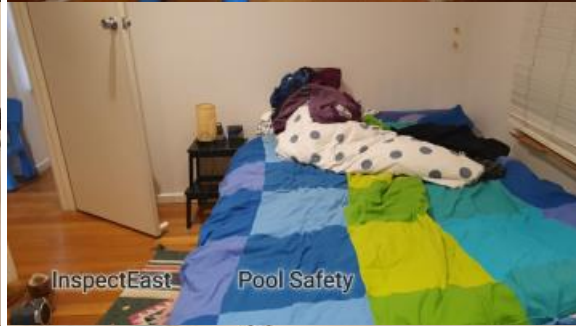
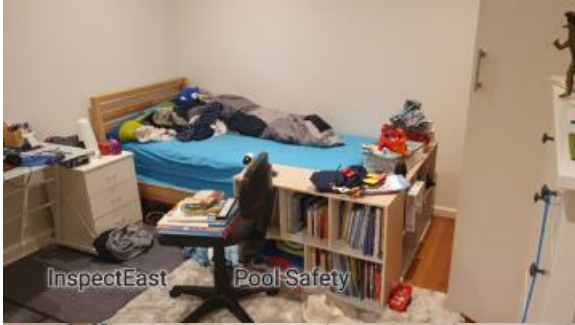
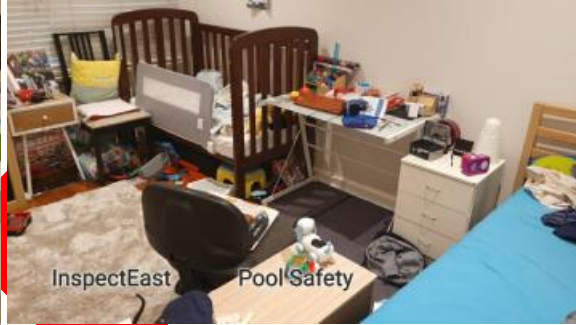
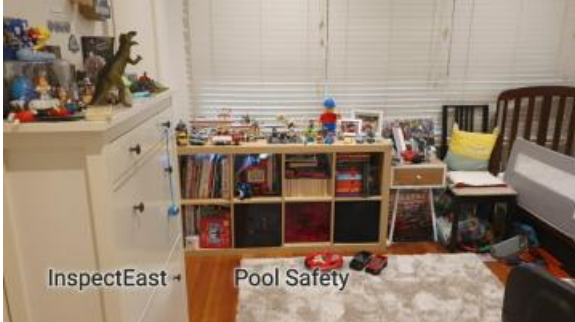
Visual limitations to floors, some walls and the robes were present due to but not limited to existing furnishings and or stored items restricting a complete evaluation of these areas and or components. Defects or timber pest may be present and not identified. Strongly recommend limitations be removed and a re-inspection be conducted to enable a more complete report to be submitted.

The external laundry door/s was locked at the time of inspection. A full evaluation of the door/s was not able to be conducted. Further investigation is recommended, as defects may be present and not detected.

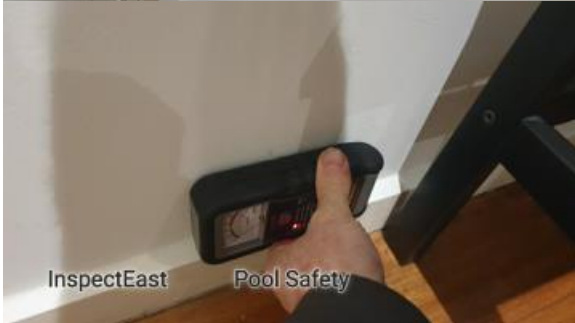
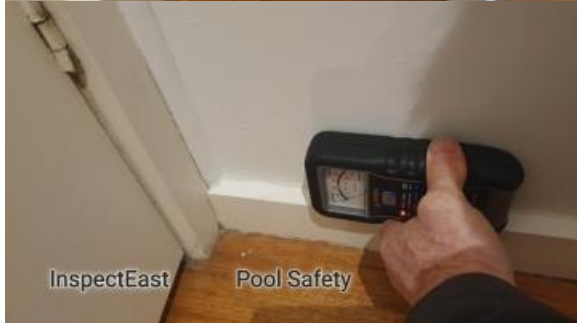
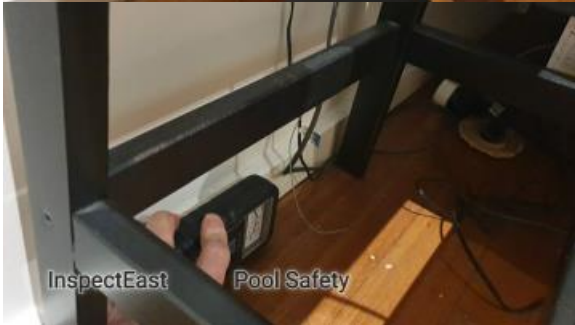
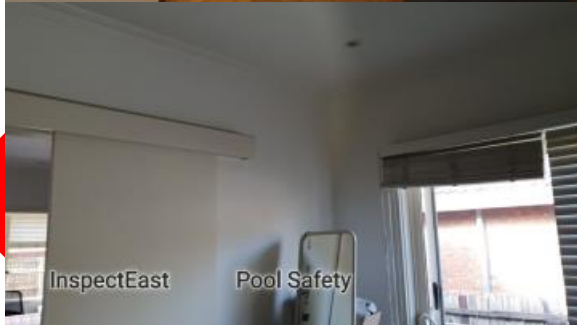
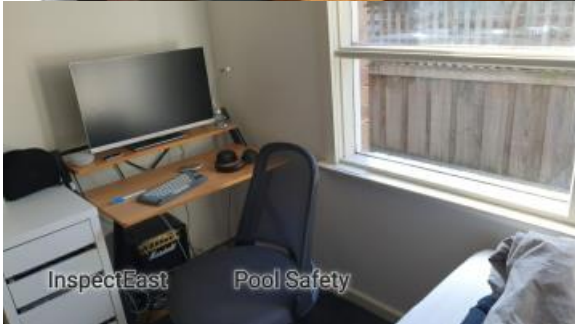
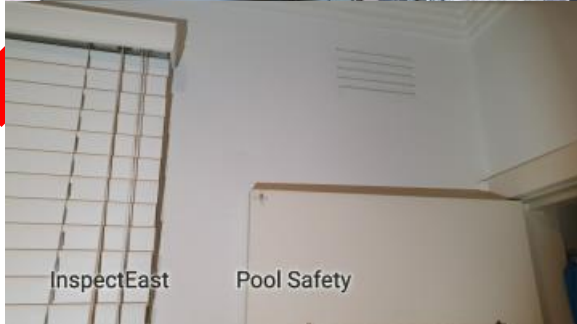
Cosmetic defective or poor surfaces were noted to wall materials within various area/s of the property and will need repair by painting by a suitably qualified plasterer and/or painter.

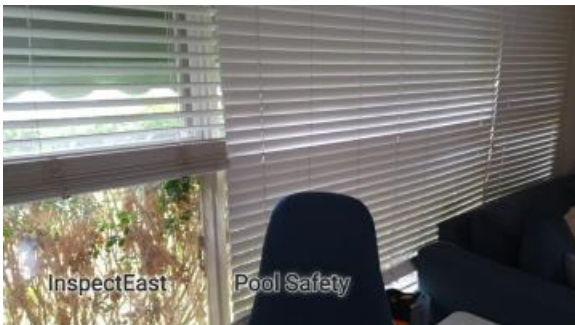
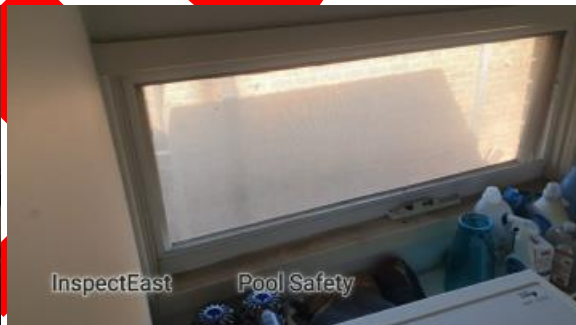
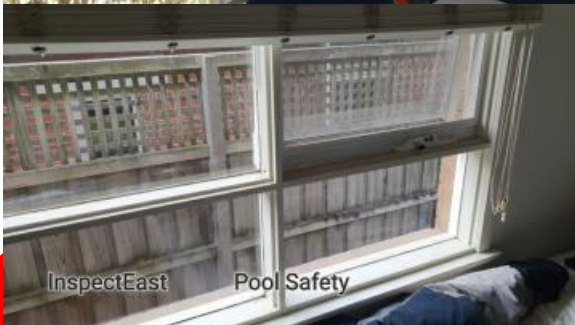
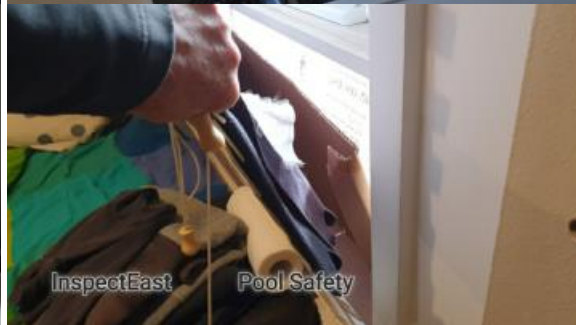
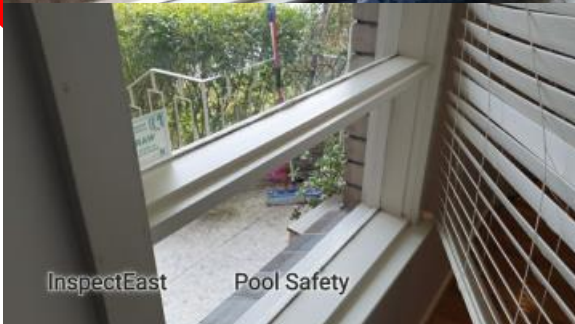
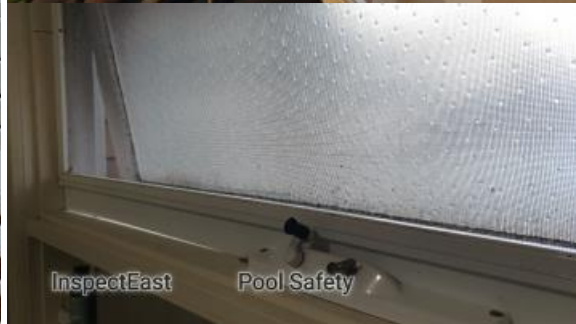
The condition of the windows and hardware is generally fair.

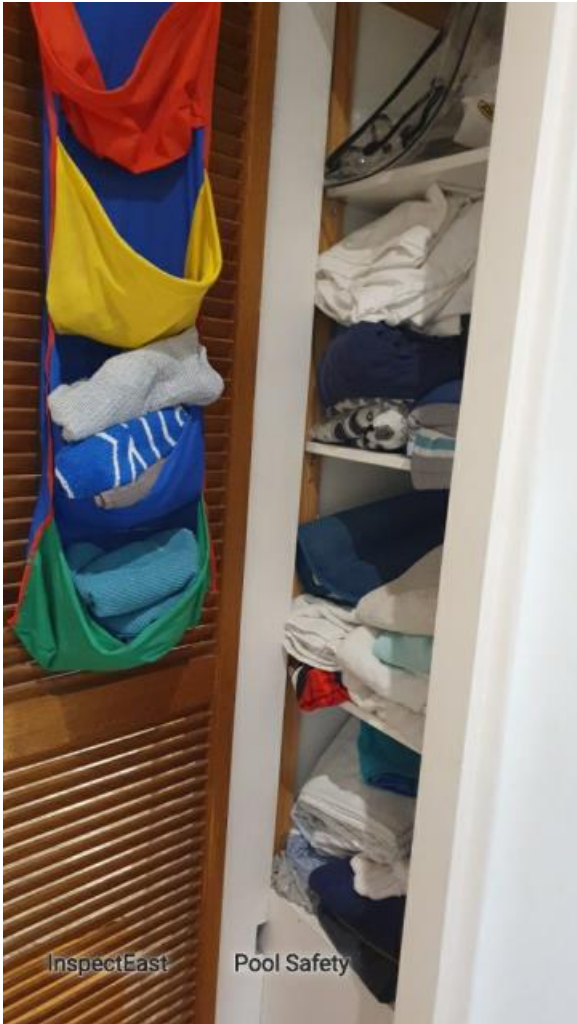
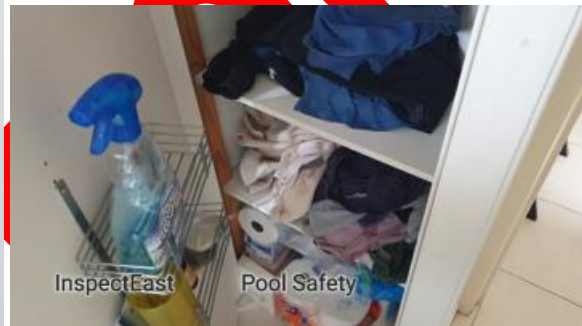
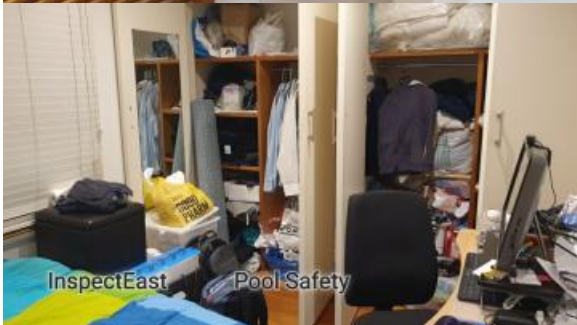
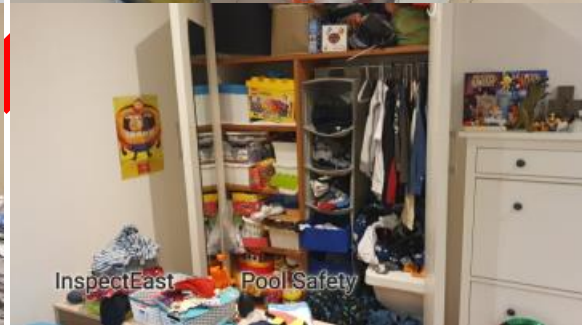
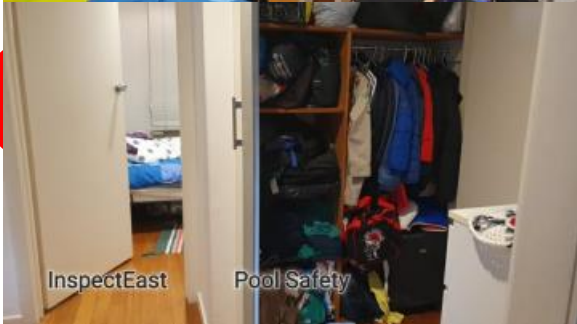
The doors bind to the laundry linen cupboard(s) and require adjustment to assure the doors function as intended. Recommendation; A licensed carpenter is required to provide a further assessment and to offer suitable rectification as required.

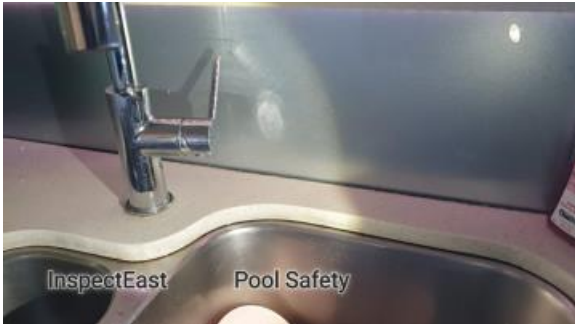
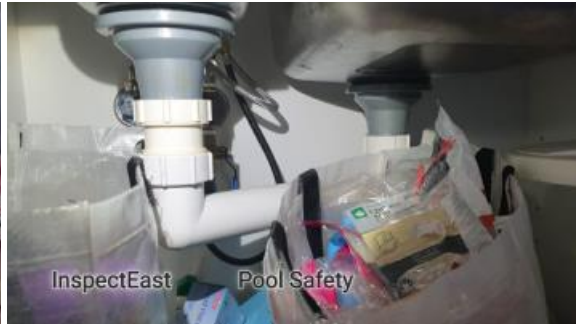
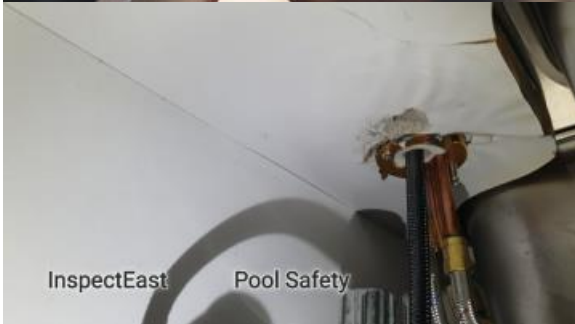
The sink & tap area appears to be leaking and requires repair or replacement by a plumber, as this free water may cause decay to surrounding components.

The leak appears to from the tap region.

The tap is loose. This will require securing by a plumber to prevent the free water causing decay to surrounding components.

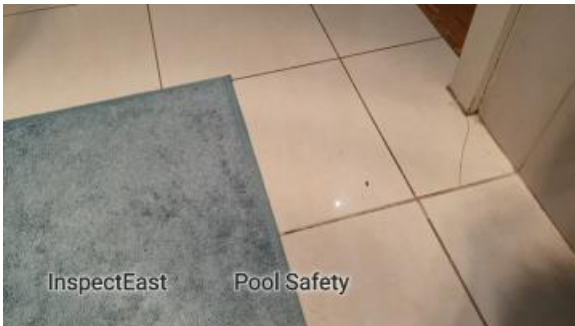
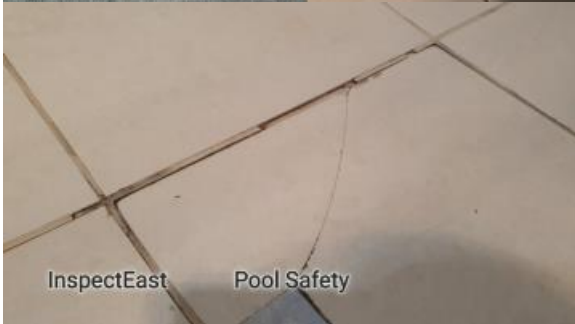
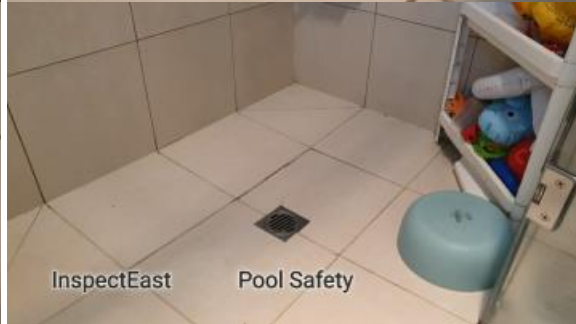
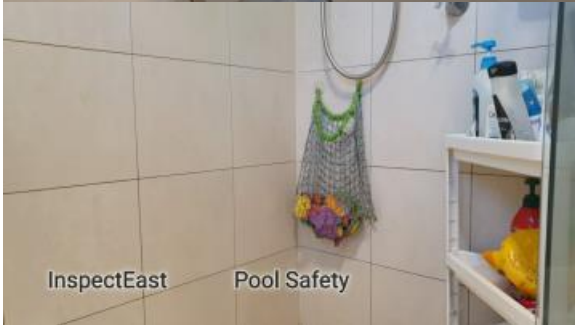
It appears the shower recess is leaking. This has caused some wet rot decay damage to the surrounding components. (Please refer to heading Subfloor and Footings- then refer to-Wood decay damage) for further information Rectification is required and the extent of works should be determined by a Licensed Builder without delay.

Note: It appears that timber floor boards has been used as the substate material to the underside of the tiled cast-in-sit-u shower base area, this is not considered a suitable material for this purpose and not considered good industry practice. This may affect the overall life span of the shower recess and may affect the warranty and performance of the waterproofing membrane if present, when conducting works to shower recesses we recommend using an industry's standard substrate as a tile baker i.e.: Scyon and/or compressed sheeting.

Note: The base structure positioned to the underside of the tiled shower base is not providing adequate support to the underside of the shower. Repairs and or additional support is required to ensure the area is suitably supported, without the correct support movement and deterioration of grout, tiles and waterproofing can occur. This can allow water to penetrate surrounding areas and cause further deterioration. A licensed carpenter is required to review and carry out suitable repairs.

The grout is loose and/or missing within the shower alcove and requires replacing by a professional tiler to prevent water penetrations and decay to surrounding components.

Note: The sealant present has mould present to the underside of the sealant. The main cause of mould growth in silicone is water getting behind the silicone, this condition is evidence that the sealant is no longer functioning as intended. Replacement is recommended as itemised in comments.

Some tiles are drummy (loose) and cracked to the shower alcove and bathroom floor. Repairs are required, and any damaged tiles should be replaced by a tiler to prevent water penetration and decay to surrounding components.

A flexible sealant should be installed by a suitably qualified professional to the gaps between the tile base and tiled shower base. This is to prevent water penetration and decay to surrounding components.

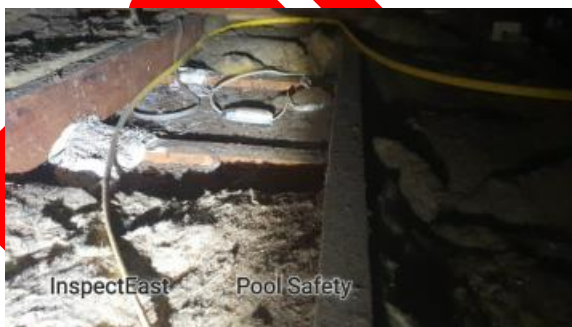
The insulation visible is not thick and full and is poorly distributed. It is not fit for purpose. We recommend that it be replaced by a suitably qualified professional to improve the overall thermal performance of the dwelling.

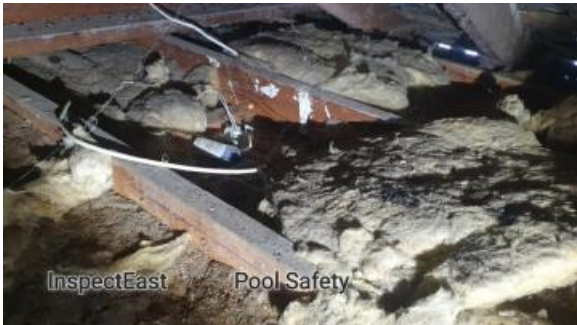
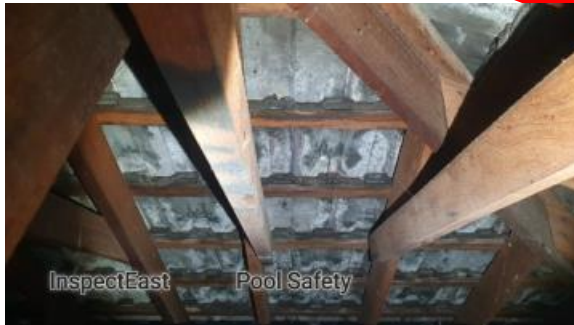
The electrical down light/s do not have fire protection cover/s installed which could present **safety hazard/ fire issue**. Fire protection cover/s should be installed by a licensed electrician as a matter of urgency.

Moderate efflorescence is noted to the underside of the roof tiles. This is when a white powdery deposit forms on the underside surface of tiles. Efflorescence is caused by moisture ingress. As the moisture enters and moves through the tiles, it dissolves mineral present, this mineral salt solution eventually finds its way to the underside of the tiles.

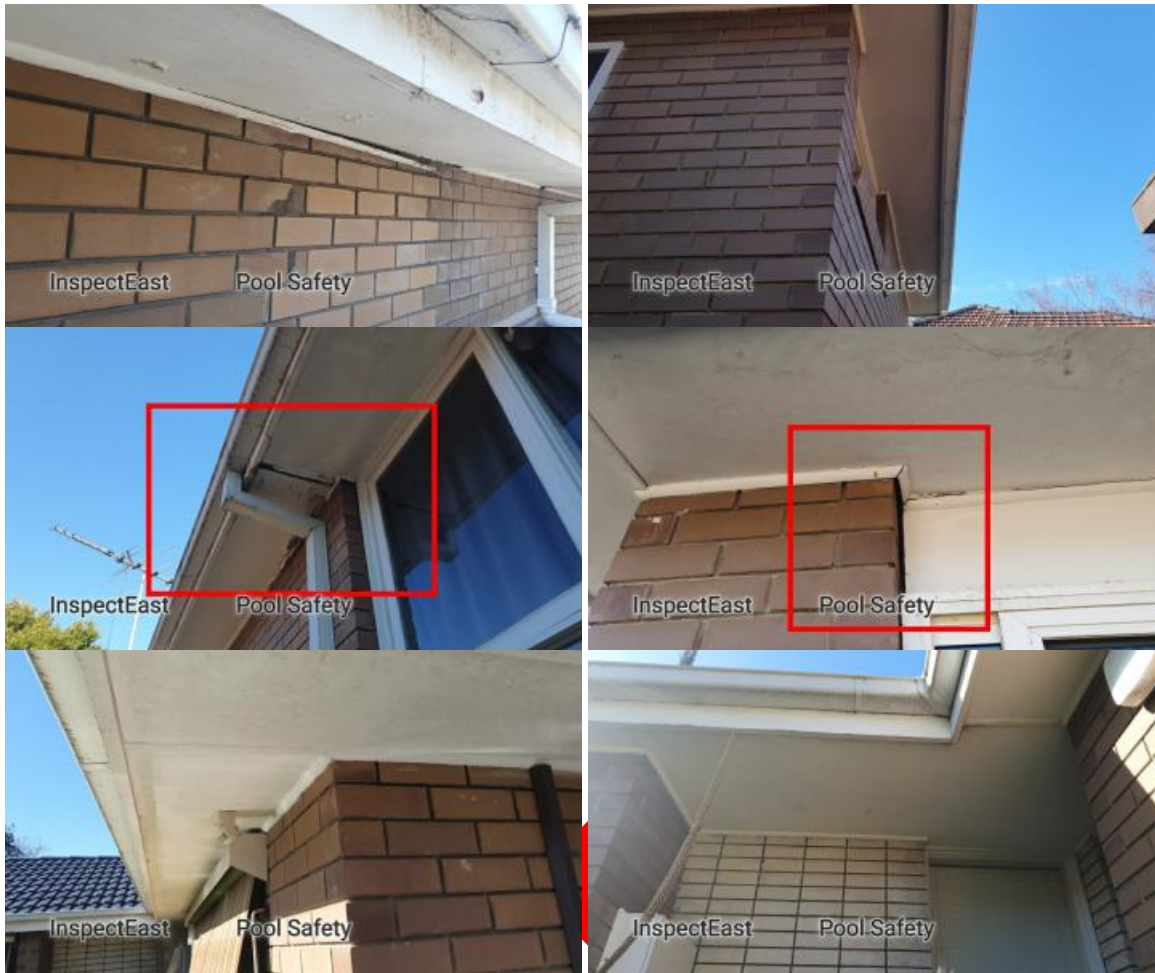
Some eaves linings are loose and or missing and gaps and holes are present (the trim section of the eaves) to the eastern, southern, and western side/s of the property and should be replaced and or repaired. A licensed carpenter should be called to install missing eave linings.

Note:- We strongly recommend that area be made vermin proof, as evidence suggests vermin are entering the property.

Water damage/staining is present to the eaves linings to the eastern side/s of the property. This should be further evaluated by a professional roof plumber to prevent further deterioration then a licensed carpenter to rectify the damage caused.

Note: This appears to past damage.

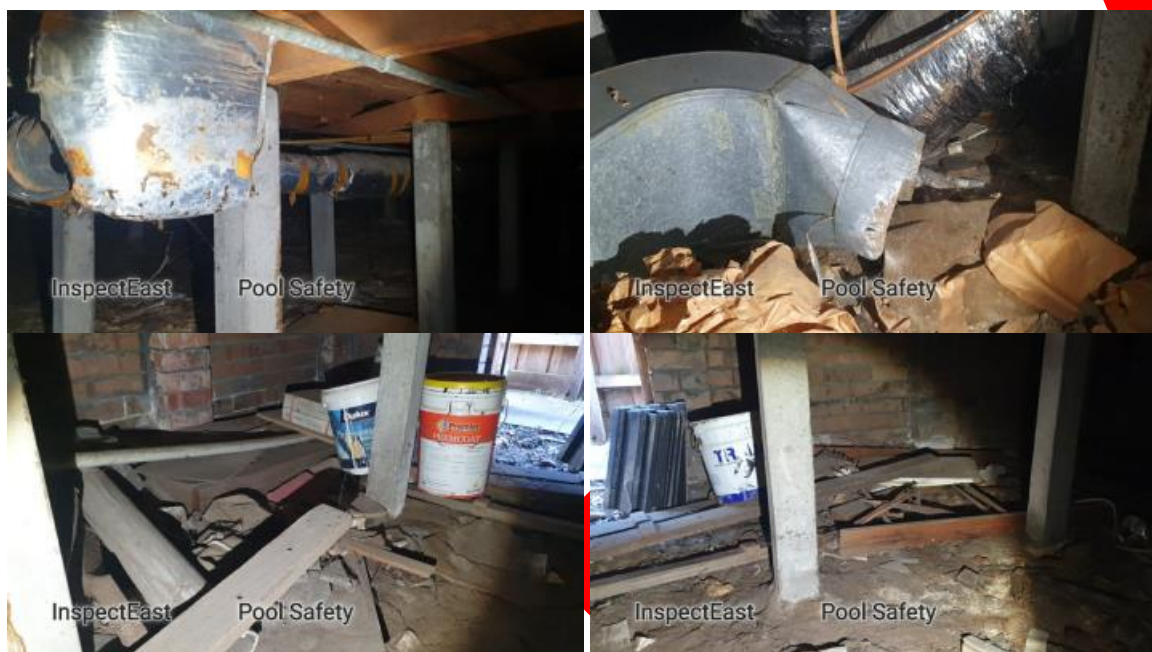
Full inspection was limited to the sub floor area by the presence of heating/cooling ducting and stored good/s. We recommend a more complete inspection of this area and removing limitations to allow full access and a re-inspection be conducted.

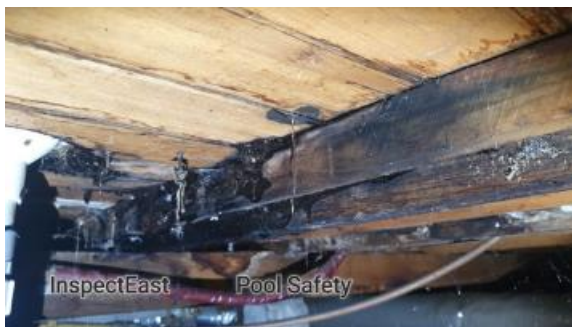
Severe wood decay damage was noted to the sub floor under the bathroom.

Damaged timbers require replacement without delay to assure the structure remains stable, the joist/s and flooring timbers are decayed, further concealed timbers may also be decayed. A licensed carpenter or licensed builder is required to provide a further assessment and to offer suitable rectification as required, and the source of the water leak repaired by a licensed plumber to prevent further deterioration.

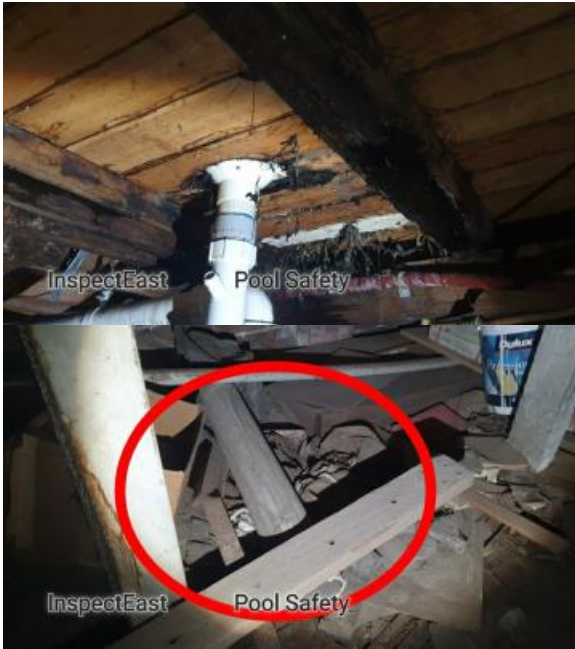
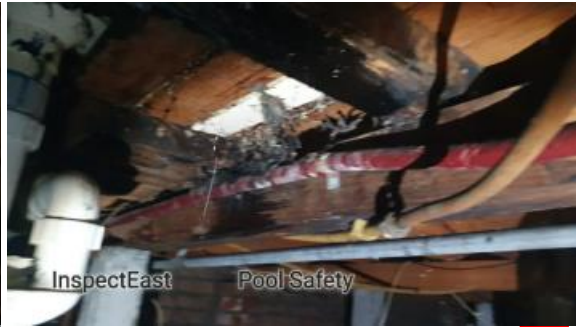
Leaks were noted in the drainage pipes under the bathroom. This has led to major decay. Please refer to the appropriate sections of the report for further details.

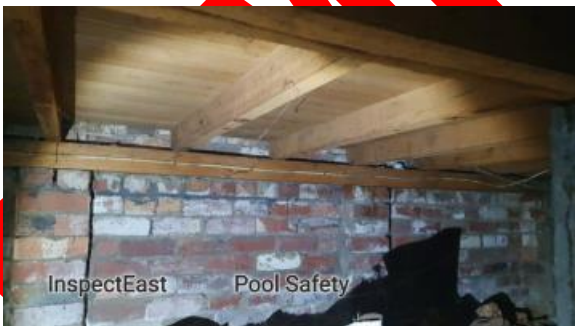
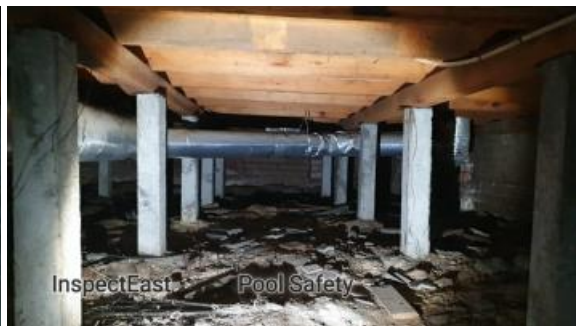
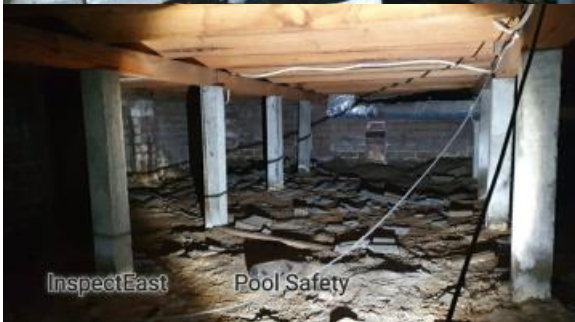
**Note:** Items and conditions present that are considered common signs footing and or foundation issues: External masonry cracking and Gap/s and or evidence of Movement to window/s frames Please refer to each section of this report for further details to the defects present.

**Recommendation:** We strongly recommend that licensed structural engineer be engaged to further investigate and offer further evaluation and repairs and/or rectification works.

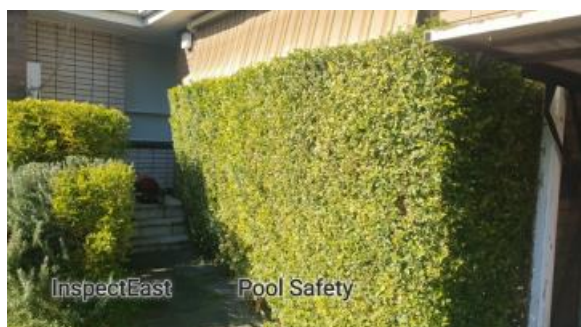
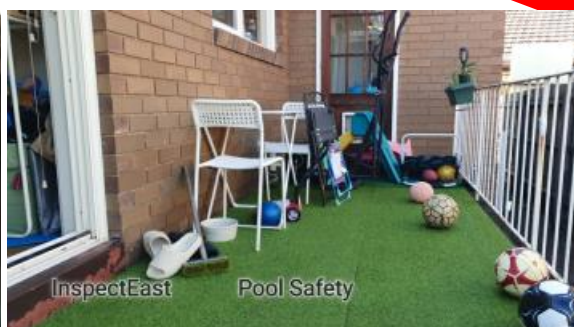
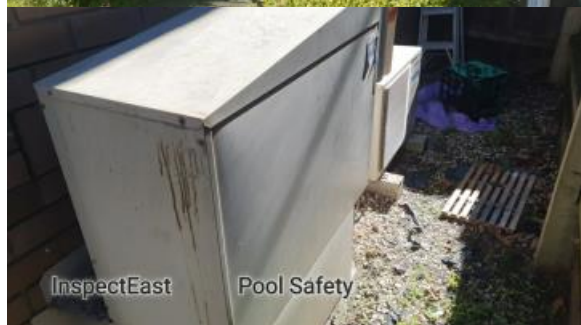
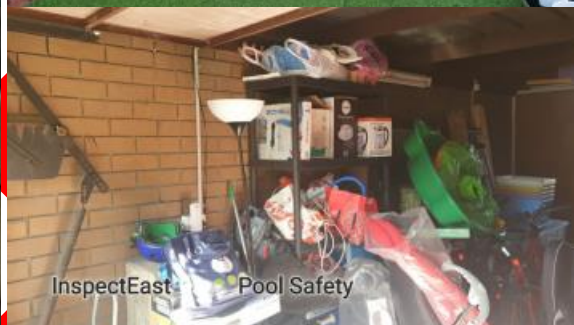
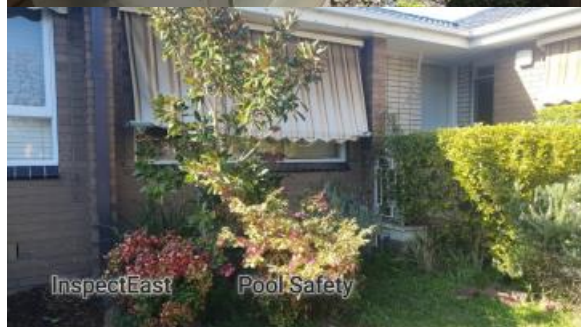
Inspection to the exterior was restricted due to Boundary and or common external walls were not inspected as access was not gained to adjoining properties. This prevented inspection. No comment is made or opinion offered where full access could not be gained. Defects and or timber pest may be present and not detected.

must be removed to enable a more complete report to be submitted. No comment is made or opinion offered where full access could not be gained. Defects and or timber pest may be present and not detected.

Defects and or damage requiring rectification may not be apparent to the inspector due to restriction. If restrictions or limitations are noted we strongly recommend further access be gained to enable a full inspection of the area(s).

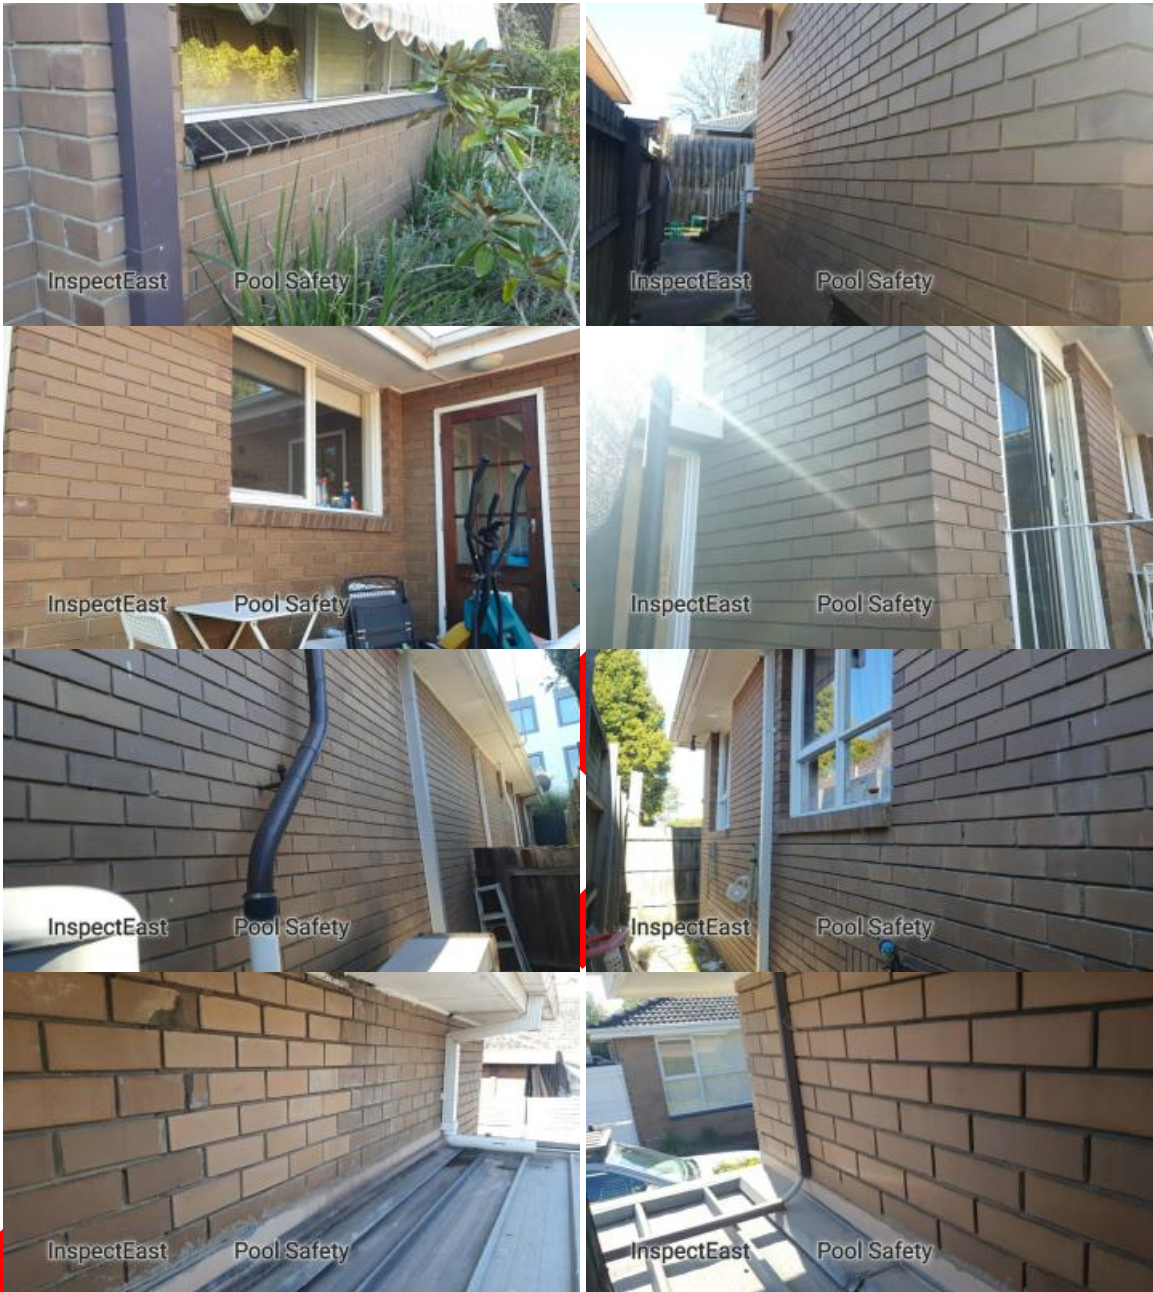
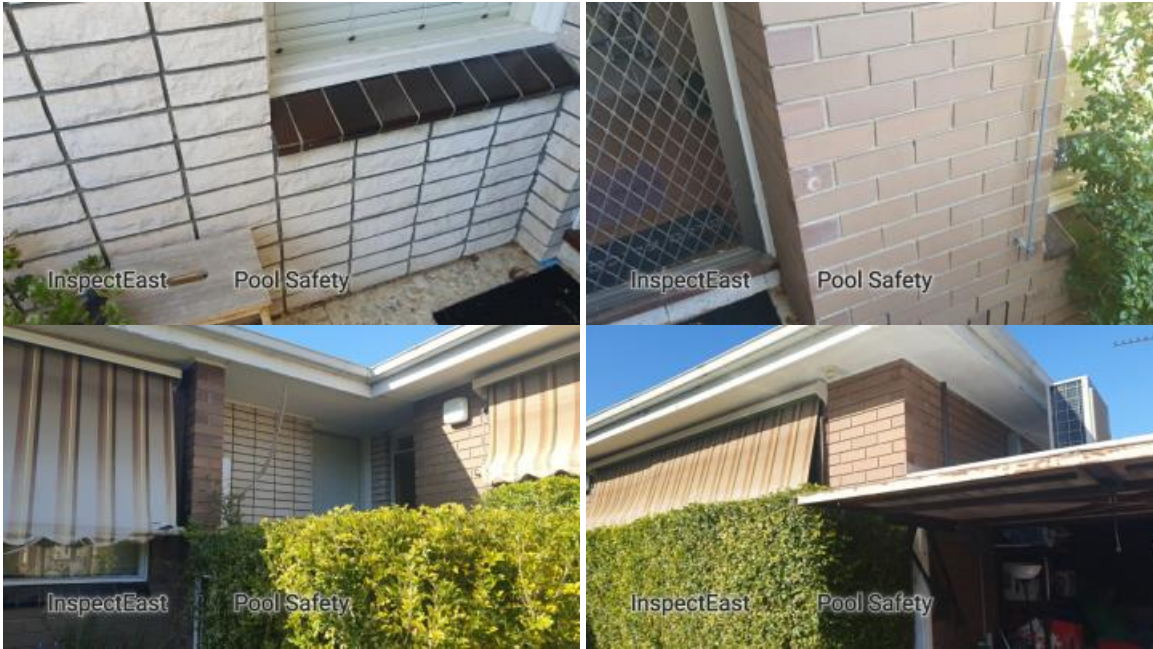
The condition of the walls is generally fair.

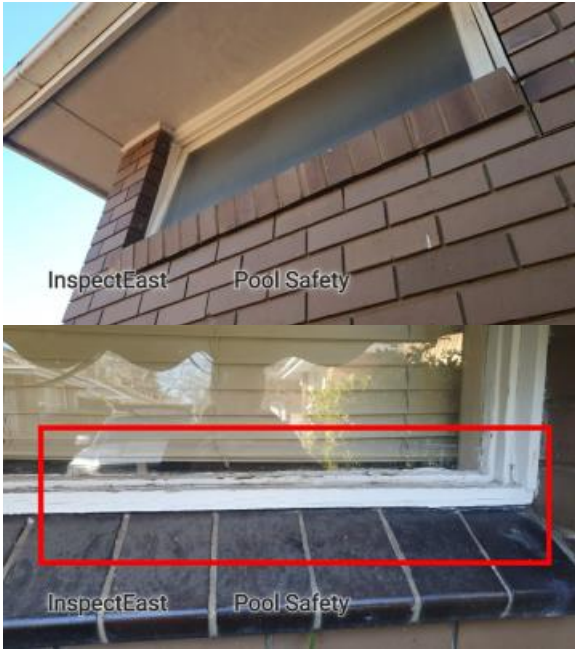
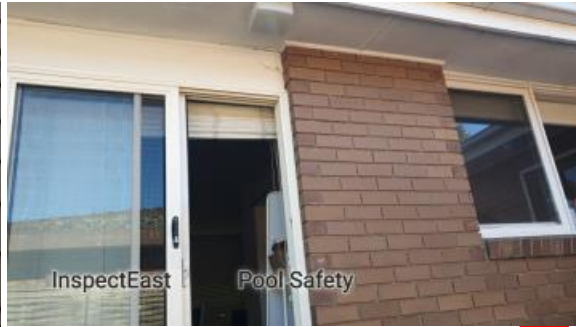
Gap/s are present to the sides of the timber windows to the eastern elevation/s of the property. We recommend that storm moulds and or infill sections are fitted to prevent potential vermin entry (i.e.: wasp etc) and or ensure water does not penetrate through this area, which could lead to decay of the surrounding components. A licensed carpenter is required to provide a further assessment and to offer suitable rectification.

Moderate rot and or decay is present to the window frames. Maintenance, repair and/or replacement will be required by a qualified carpenter. This was observed to the western side/s of the property. A licensed carpenter required to provide a further assessment and to offer suitable rectification as required.

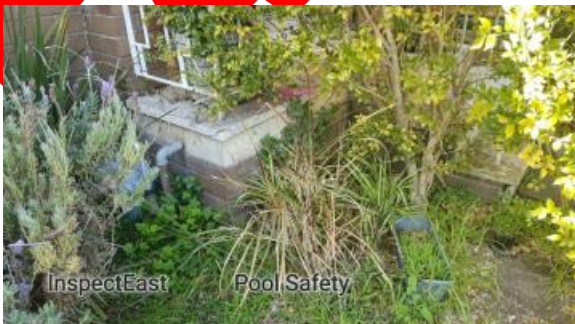
Metal balustrades and or handrails are rusted to the stairs and treatment with an anti-rust paint is required to prolong the life of the material. A licensed painter is required to provide a further assessment and to offer suitable rectification as required.

Some cracked and drummy tiles were noted to the stairs. Replacement of damaged tiles is recommended. A professional tiler should be called to conduct suitable repairs.

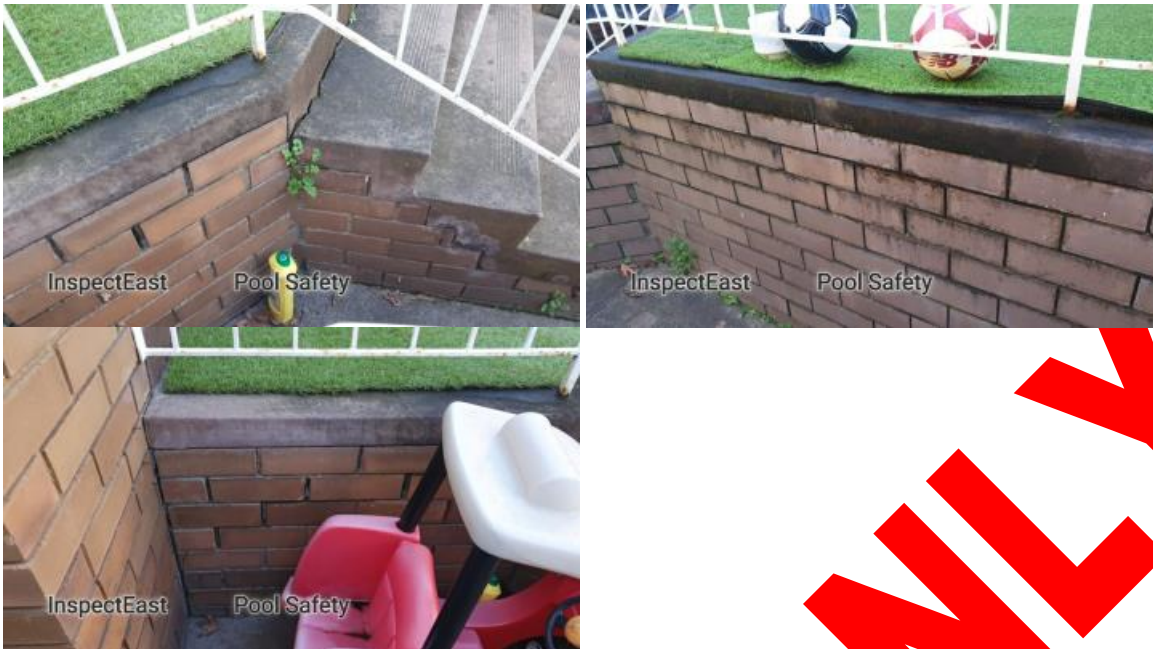
Metal balustrades and or handrails are rusted to the stairs and treatment with an anti-rust paint is required to prolong the life of the material. A licensed painter is required to provide a further assessment and to offer suitable rectification as required.

Gaps are present between the stair structure and the wall of the dwelling. This is allowing water to penetrate the affected areas and this is causing water related damage to the subfloor area. We strongly recommend that a suitably qualified professional is engaged to caulk and waterproof the area to prevent further deterioration.

Minor to moderate movement is evident to the concrete stairs. This will require some maintenance or repair by a concreter, as its possible this movement may present as a safety issue in the future.

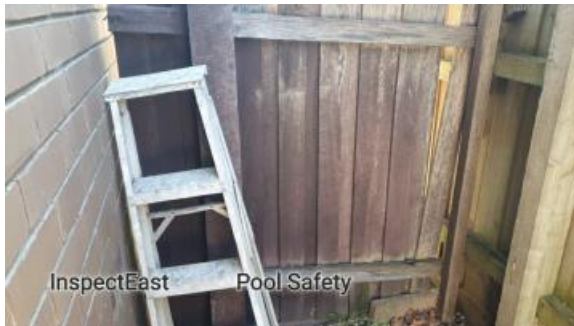
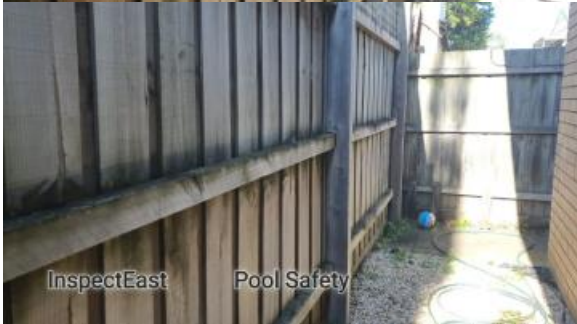
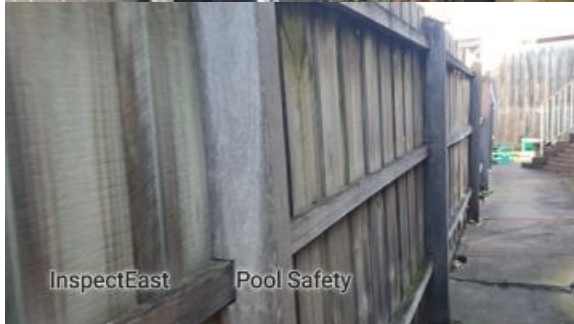
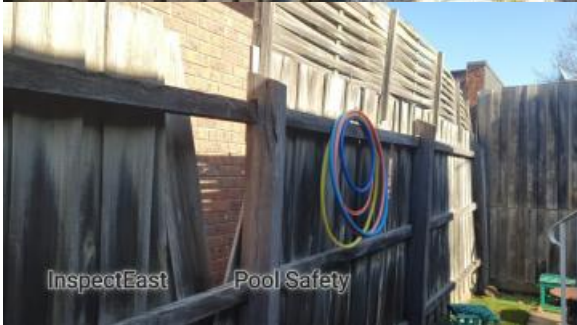
Note: Repairs or maintenance is required. The fences are leaning to the rear side/s of the property. We recommend repairs are carried out by a licensed carpenter to assure the fences remain secure.

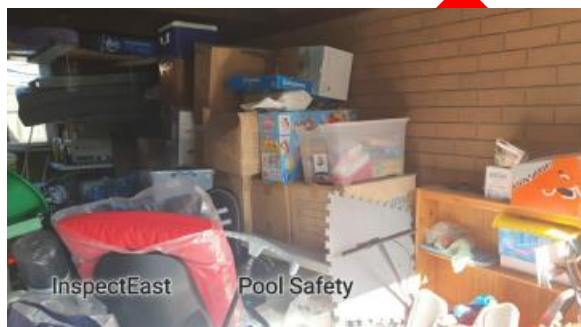
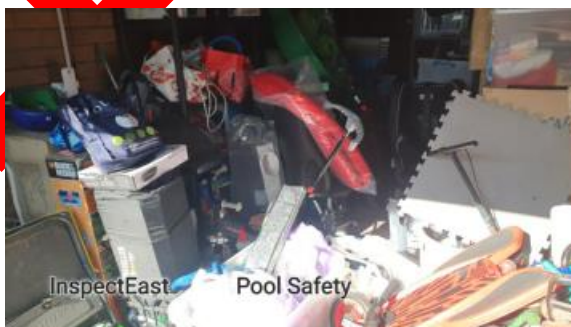
Stored items restricted inspection to the interior. These goods must be removed to enable a more complete report to be submitted. Defects and or timber pest may be present and not detected.

Boundary and or common external walls were not inspected as access was not gained to adjoining properties.

Defects and or damage requiring rectification may not be apparent to the inspector due to restriction. If restrictions or limitations are noted we STRONGLY recommend further access be gained to enable a full inspection of the area(s) prior to making a decision on this property.

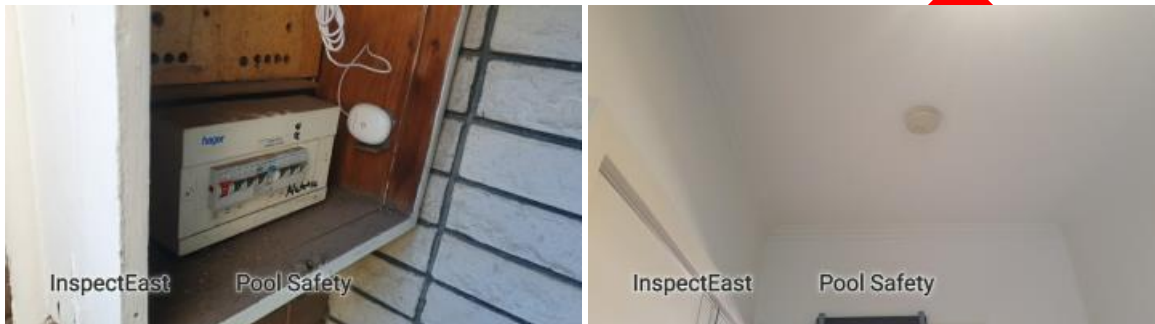
Power supply is protected by RCD (Residual Current Device) safety switching on power circuit/s and by visual observation is not considered defective. We recommend contacting a licensed electrician to assure the electrical safety switch is functioning as intended and as verification safety performance of the RCD (Residual Current Device).

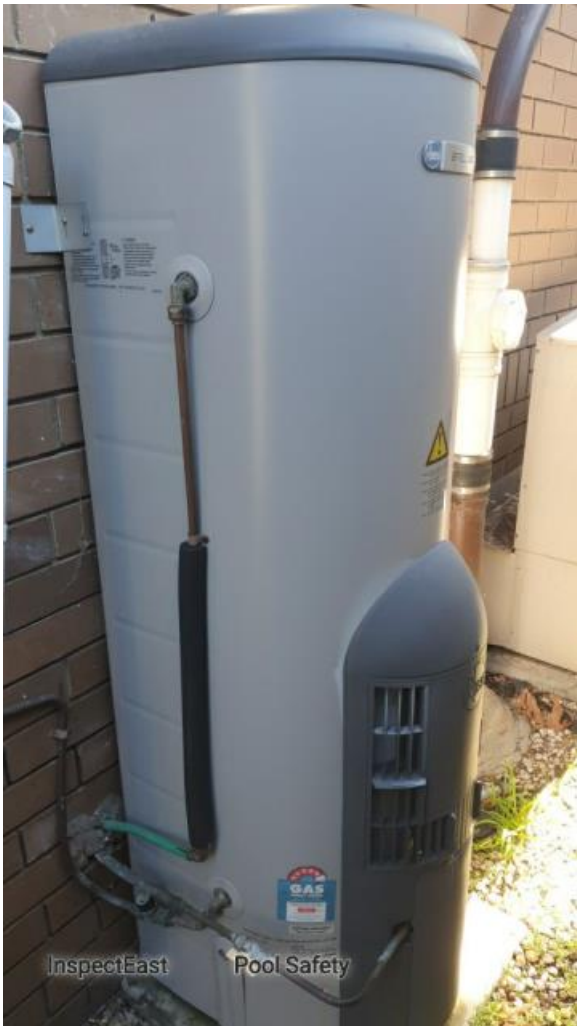
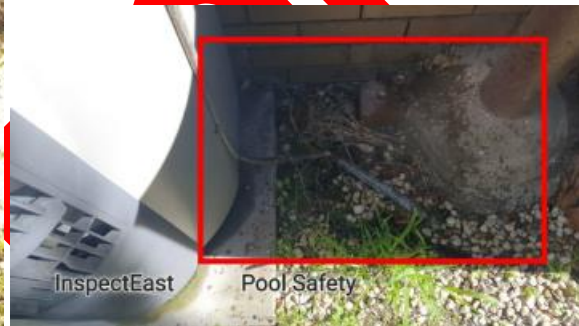
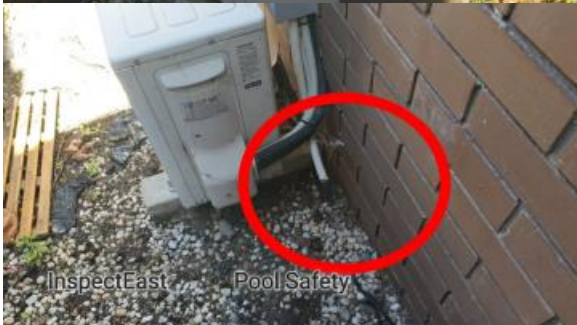
The hot water system appears to be in working condition. No specific tests other than running the hot water from a tap was carried out. No determination has been made as to the suitability or adequacy of the hot water system in relation to capacity or otherwise. The overflow pipe/s to the hot water service and air conditioning split system/s is not connected to the storm water system. This can affect the timber pest management of the property and also the free water next to the dwelling may have an adverse effect on the foundations. Recommend the overflow/s be connected to the stormwater system by a licensed plumber.

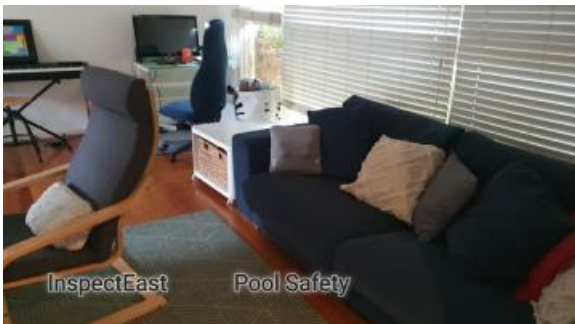
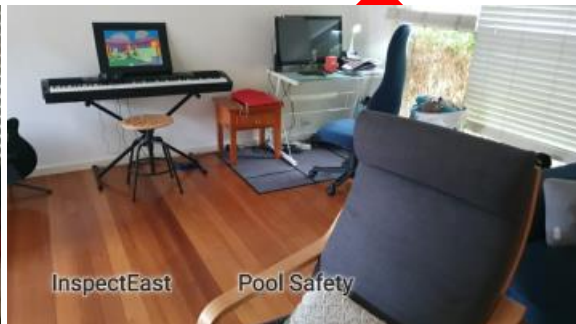
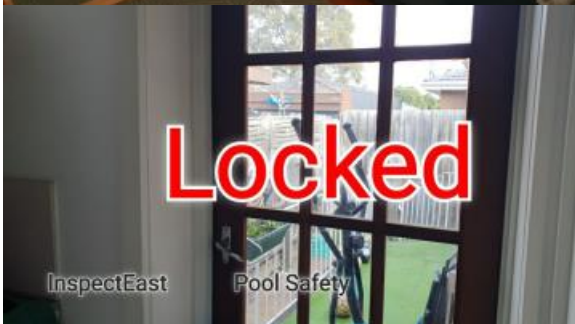
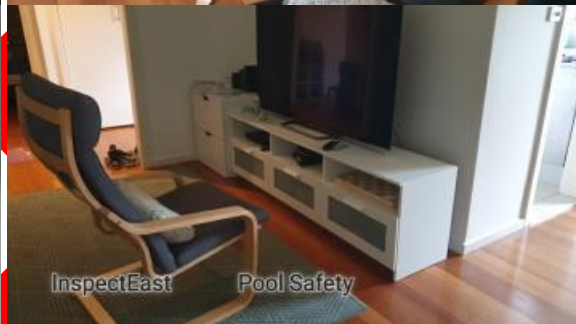
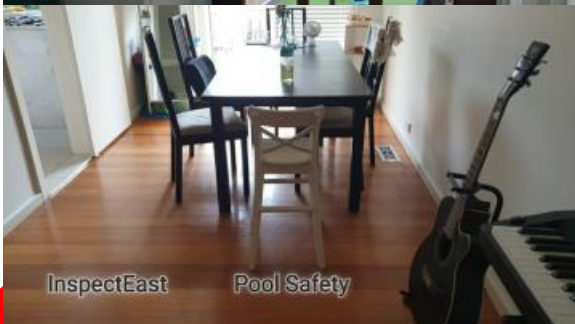
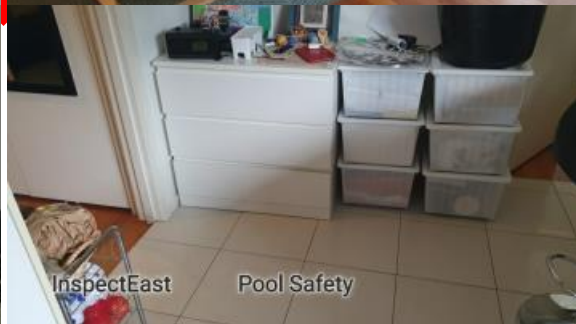
Visual limitations to floors, some walls and the robes were present due to but not limited to existing furnishings and or stored items restricting a complete evaluation of these areas and or components. Defects or timber pest may be present and not identified. Strongly recommend limitations be removed and a re-inspection be conducted to enable a more complete report to be submitted.

The external laundry door/s was locked at the time of inspection. A full evaluation of the door/s was not able to be conducted. Further investigation is recommended, as defects may be present and not detected.
