## Building & Pest Inspection Report

##/5## ##### Avenue  
#####, Vic

August 1, 2024

Report: 6430-b&p

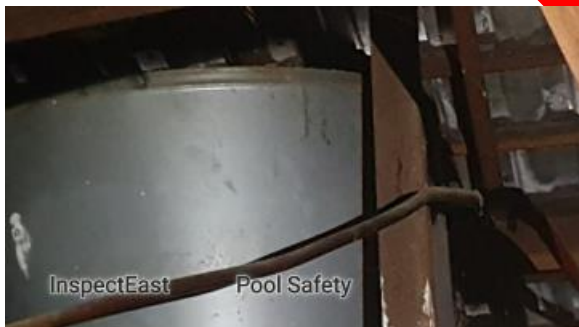
Inspection over the eaves and low areas to the perimeter of the building was restricted due to the low pitch and method of construction allowing only a limited visual inspection from a distance. Items such as top plates and ceiling and roof framing in these areas was not able to be fully inspected. Defects and or timber pest may be present and not detected.

A hot water tank and support frame is present in the roof void restricting inspection of this area. We recommend the unit be removed by a suitably qualified professional to enable a more complete inspection to be conducted.

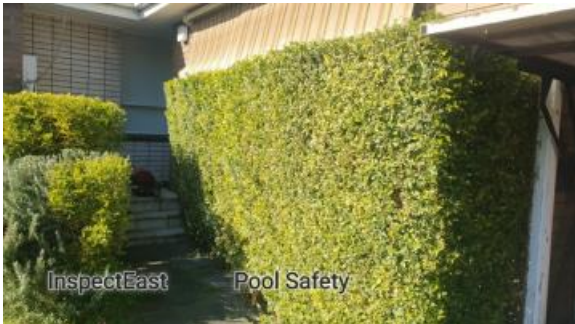
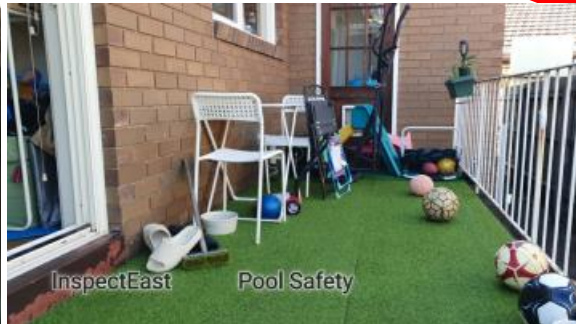
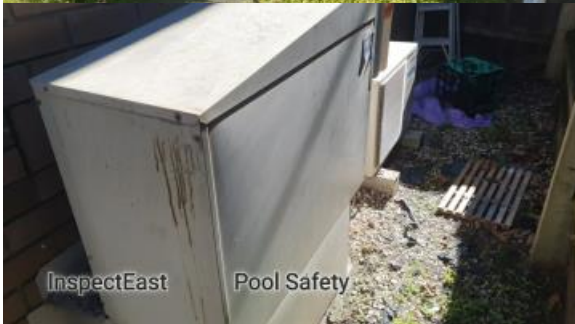
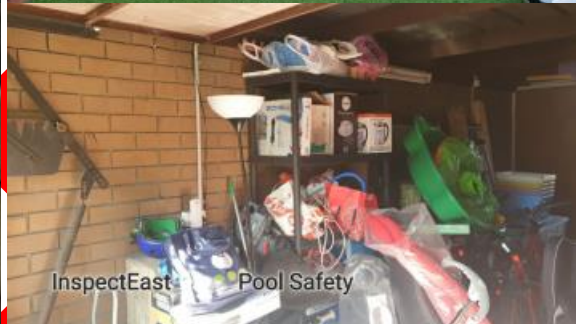
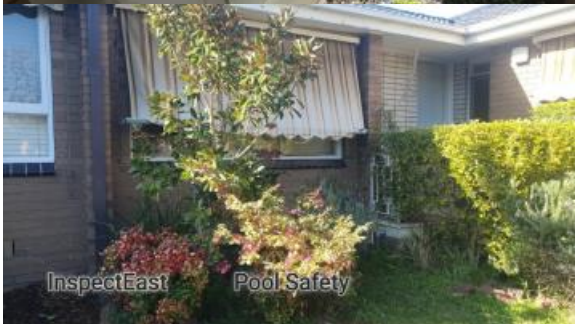
Inspection to the exterior was restricted due to Boundary and or common external walls were not inspected as access was not gained to adjoining properties. This prevented inspection. No comment is made or opinion offered where full access could not be gained. Defects and or timber pest may be present and not detected.

must be removed to enable a more complete report to be submitted. No comment is made or opinion offered where full access could not be gained. Defects and or timber pest may be present and not detected.

Active termites or other timber damaging pests may be present and not detected in areas where inspection was limited, obstructed or access was not gained. If restrictions or limitations are noted we strongly recommend further access be gained to enable a full inspection of the area(s). See Section 2.0 - Reasonable Access.

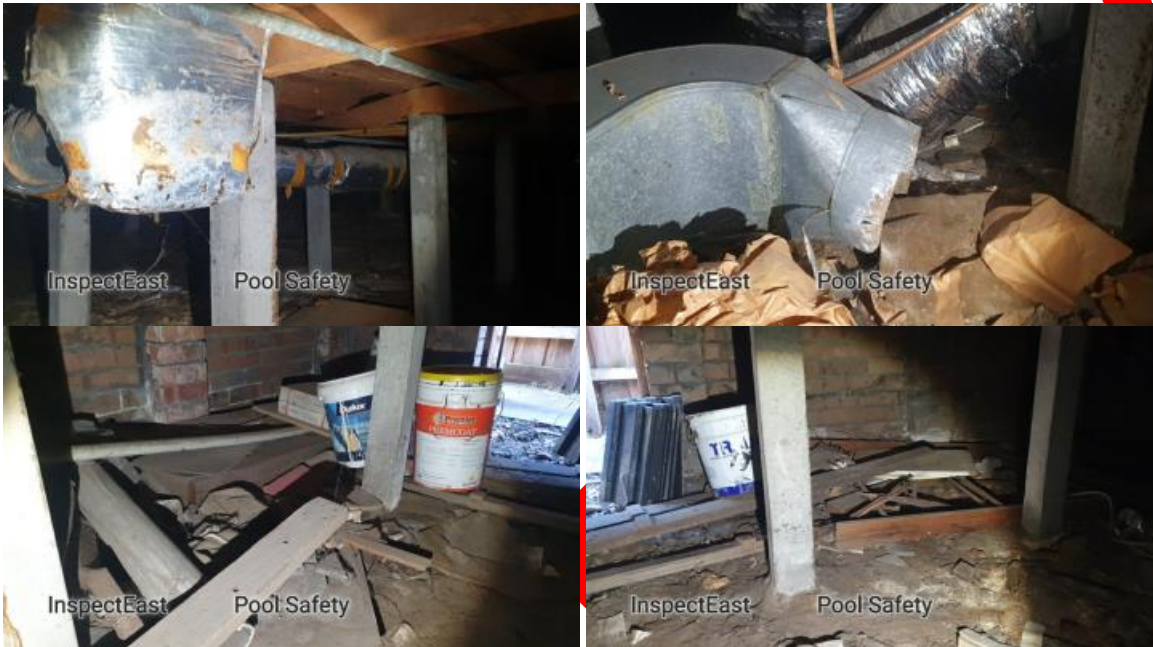
#### Cavity Present/Not Accessible

Full inspection was limited to the sub floor area by the presence of heating/cooling ducting and stored good/s. We recommend a more complete inspection of this area and removing limitations to allow full access and a re-inspection be conducted.

Active termites or other timber damaging pests may be present and not detected in areas where inspection was limited, obstructed or access was not gained. If restrictions or limitations are noted we strongly recommend further access be gained to enable a full inspection of the area(s). See Section 2.0 - Reasonable Access.

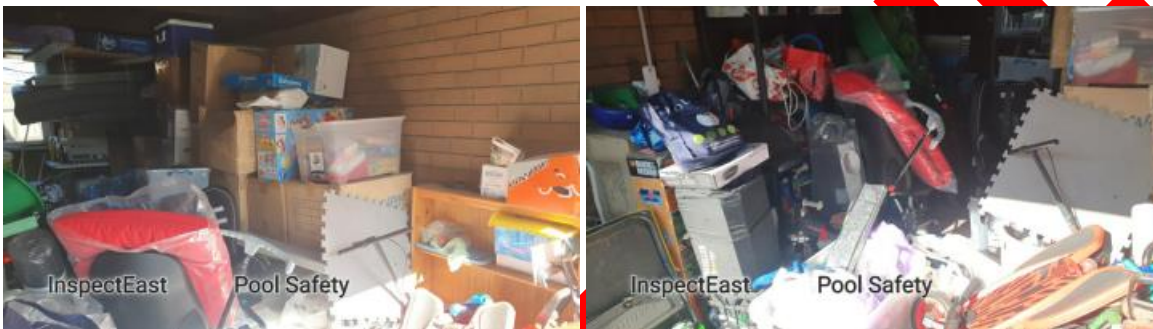
Stored items restricted inspection to the interior. These goods must be removed to enable a more complete report to be submitted. Defects and or timber pest may be present and not detected.

Boundary and or common external walls were not inspected as access was not gained to adjoining properties.

Active termites or other timber damaging pests may be present and not detected in areas where inspection was limited, obstructed or access was not gained. If restrictions or limitations are noted we recommend further access be gained to enable a full inspection of the area(s). See Section 2.0 - Reasonable Access.
